Access Compliance Report

Public Rights-of-Way

(Curb Ramps)

Intersection ID: 23568	Main Street: CASTLEGATE_DR	Cross Street: RUGBY_LN	Location: NE
ADA ID: 46E271BEE06B	Ramp Type: PerpDiag	Initial Pass/Fail: Fail	Overall Compliance: No
Severity Score: 58.75			
Codes/Mitigation Info/Possible Solution		Field Measurements/Component Compliance

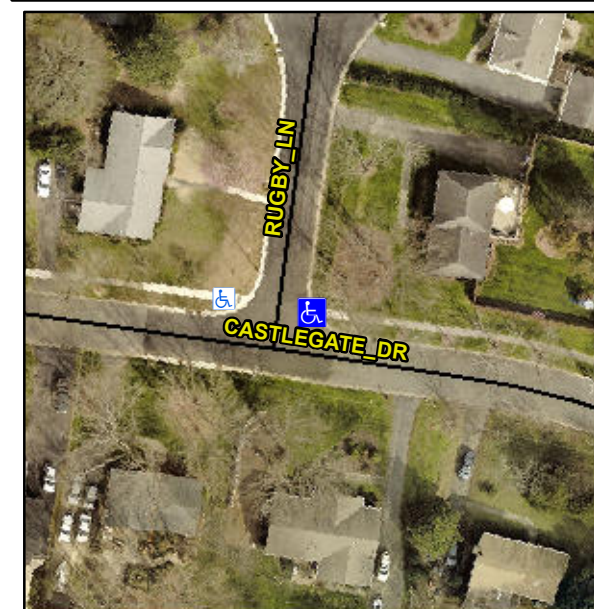
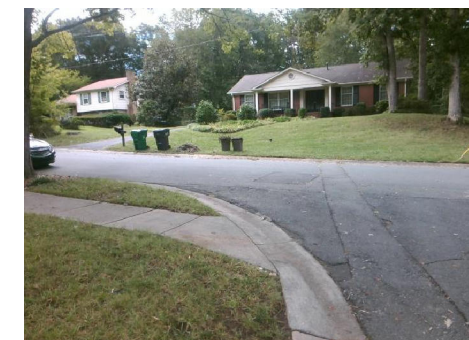
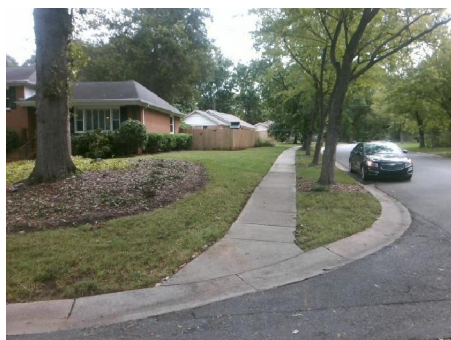
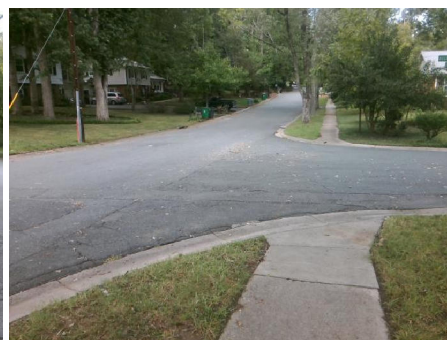
Not Found, R304.5.1, R304.2.2, R304.5.3

Compliance	Description	Data	Compliance	Description	Data
N/A	Ramp Length (in)	30.0	No	Ramp Slope (%)	12.6
No	Ramp Width (in)	46.5	No	Ramp XSlope (%)	7.6
N/A	Flare Type LT	N/A	N/A	Flare Type RT	N/A
N/A	Flare Slope LT (%)	N/A	N/A	Flare Slope RT (%)	N/A
N/A	Flare Traversable LT?	N/A	N/A	Flare Traversable RT?	N/A
N/A	Landing Length (in)	N/A	N/A	DWS Provided?	N/A
N/A	Landing Width (in)	N/A	N/A	DWS Contrast?	N/A
N/A	Landing Slope (%)	N/A	N/A	DWS Length (in)	N/A
N/A	Landing X Slope (%)	N/A	N/A	DWS Full Width?	N/A
N/A	Landing Curb? (Y/N)	N/A	N/A	DWS Offset (in)	N/A
N/A	Shared Landing?	N/A			
N/A	Gutter Ponding?	N/A	N/A	Gutter Slope (%)	N/A
N/A	Gutter Lip Ht (in)	N/A	N/A	Gutter X Slope (%)	N/A
N/A	Painted X Walk1?	No	N/A	Painted X Walk2?	No
	X Walk 1 Direction	To NW		X Walk 2 Direction	To SW
N/A	X Walk 1 Width (in)	N/A	N/A	X Walk 2 Width (in)	N/A
	X Walk 1 Slope (%)	1.2		X Walk 2 Slope (%)	3.0
	X Walk 1 X Slope (%)	2.1		X Walk 2 X Slope (%)	3.3

N/A	Ramp inside XWalk1?	N/A	N/A	Ramp inside XWalk2?	N/A
	Road Slope (%)	3.4	N/A	Clear Space?	N/A
	Road X Slope (%)	3.2	N/A	Clear Space to XWalk (in)	N/A
N/A	Any Obstructions?	N/A	N/A	Storm Grate/Utility Hazard?	N/A
	Obstruction Type			Storm Grate/Utility Type	
		N/A			N/A
			Yes	Surface Condition? (G/P)	Good

Remove & Replace Curb Ramp With Two New Directional Ramps or Equivalent.
