Access Compliance Report

Public Rights-of-Way

(Curb Ramps)

Intersection ID: 15036	Main Street: MAGNOLIA_AV	Cross Street: MCDONALD_AV	Location: SE
ADA ID: 46E828410325	Ramp Type: Directional1	Initial Pass/Fail: Fail	Overall Compliance: No
		Severity Score: 13.75

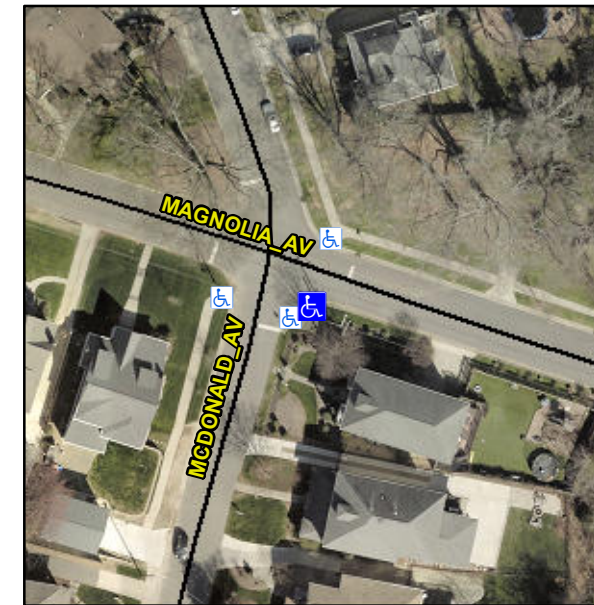
NO LNDG

R304.2.2, R304.5.3

Compliance	Description	Data	Compliance	Description	Data
N/A	Ramp Length (in)	154.0	N/A	Grade Break?	N/A
Yes	Ramp Width (in)	57.0	N/A	Grade Break Slope (%)	0.0
No	Ramp Slope (%)	11.4	N/A	Grade Break XSlope (%)	0.0
No	Ramp XSlope (%)	3.3			
N/A	Flare Type LT	N/A	N/A	Flare Type RT	N/A
N/A	Flare Slope LT (%)	N/A	N/A	Flare Slope RT (%)	0.0
N/A	Flare Traversable LT?	N/A	N/A	Flare Traversable RT?	N/A
N/A	Landing Length (in)	0.0	N/A	DWS Provided?	N/A
N/A	Landing Width (in)	0.0	N/A	DWS Contrast?	N/A
N/A	Landing Slope (%)	0.0	N/A	DWS Length (in)	N/A
N/A	Landing X Slope (%)	0.0	N/A	DWS Full Width?	N/A
N/A	Landing Curb? (Y/N)	N/A	N/A	DWS Offset LT (in)	N/A
N/A	Shared Landing?	N/A	N/A	DWS Offset RT (in)	N/A
N/A	Gutter Ponding?	0.0	N/A	Gutter Slope (%)	N/A
N/A	Gutter Lip Ht (in)	0.0	N/A	Gutter X Slope (%)	N/A
N/A	Painted X Walk1?	No		Road Slope (%)	2.9
	X Walk 1 Direction	To N		Road X Slope (%)	6.0
	X Walk 1 Width (in)	N/A		Clear Space?	N/A

X Walk 1 Slope (%)	2.9	N/A	Clear Space to XWalk (in)	N/A
	X Walk 1 X Slope (%)	6.0	N/A	Storm Grate/Utility Hazard?	N/A
N/A	Ramp inside XWalk1?	N/A		Storm Grate/Utility Type	
N/A	Any Obstructions?	N/A			N/A
	Obstruction Type		Yes	Surface Condition? (G/P)	Good
			N/A	Curb Slope (%)	10.2

Remove & Replace Entire Ramp.
