# Access Compliance Report

## Public Rights-of-Way

### (Curb Ramps)

| Intersection ID: N/A | Main Street: SCOFIELD_RD | Cross Street: WINTERCREST_LN | Location: E |

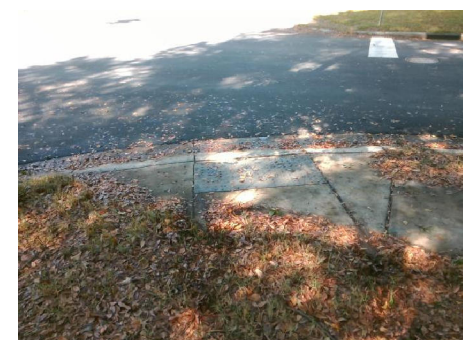
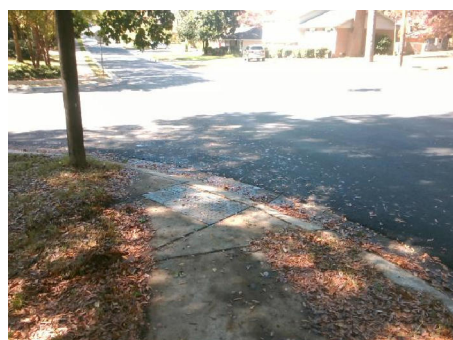
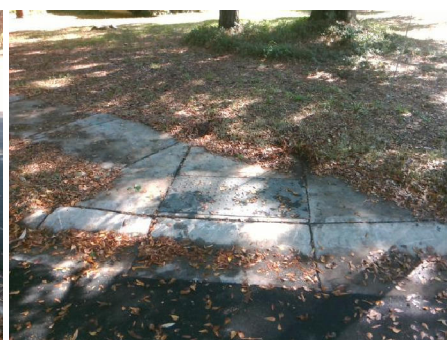
| ADA ID: 470E24D07FC5 | Ramp Type: PerpDiag | Initial Pass/Fail: Fail | Overall Compliance: No |

**Not Found, R304.5.3**

| Compliance | Description | Data | Compliance | Description | Data |
|---|---|---|---|---|---|
| Yes | Ramp Width (in) | 48.0 | No | Ramp XSlope (%) | 4.1 |

**Remove & Replace Curb Ramp With Two New Directional Ramps or Equivalent.**
