# Access Compliance Report

## Public Rights-of-Way

### (Curb Ramps)

Intersection ID: N/A	Main Street: BRECKFIELD_CT	Cross Street: KIRKWYND_COMMONS_DR	Location: SE
ADA ID: 471CD35273AB	Ramp Type: PerpDiag	Initial Pass/Fail: Fail	Overall Compliance: No
Codes/Mitigation Info/Possible Solution		Field Measurements/Component Compliance	
Severity Score: 21.25

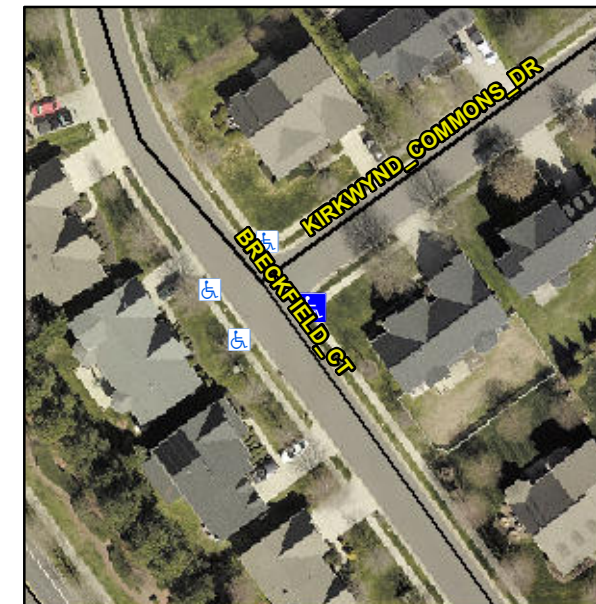
Compliance	Description	Data	Compliance	Description	Data
N/A	Ramp Length (in)	47.0	No	Ramp Slope (%)	8.8
No	Ramp Width (in)	47.0	Yes	Ramp XSlope (%)	1.0
N/A	Flare Type LT	N/A	N/A	Flare Type RT	N/A
N/A	Flare Slope LT (%)	N/A	N/A	Flare Slope RT (%)	N/A
N/A	Flare Traversable LT?	N/A	N/A	Flare Traversable RT?	N/A
N/A	Landing Length (in)	N/A	N/A	DWS Provided?	N/A
N/A	Landing Width (in)	N/A	N/A	DWS Contrast?	N/A
N/A	Landing Slope (%)	N/A	N/A	DWS Length (in)	N/A
N/A	Landing X Slope (%)	N/A	N/A	DWS Full Width?	N/A
N/A	Landing Curb? (Y/N)	N/A	N/A	DWS Offset (in)	N/A
N/A	Shared Landing?	N/A			
N/A	Gutter Ponding?	N/A	N/A	Gutter Slope (%)	N/A
N/A	Gutter Lip Ht (in)	N/A	N/A	Gutter X Slope (%)	N/A
N/A	Painted X Walk1?	No	N/A	Painted X Walk2?	No
	X Walk 1 Direction	To NW		X Walk 2 Direction	To SW
N/A	X Walk 1 Width (in)	N/A	N/A	X Walk 2 Width (in)	N/A
	X Walk 1 Slope (%)	1.9		X Walk 2 Slope (%)	5.2
	X Walk 1 X Slope (%)	1.2		X Walk 2 X Slope (%)	0.6

N/A	Ramp inside XWalk1?	N/A	N/A	Ramp inside XWalk2?	N/A
	Road Slope (%)	1.1	N/A	Clear Space?	N/A
	Road X Slope (%)	2.1	N/A	Clear Space to XWalk (in)	N/A
N/A	Any Obstructions?	N/A	N/A	Storm Grate/Utility Hazard?	N/A
	Obstruction Type			Storm Grate/Utility Type	
		N/A			N/A
			Yes	Surface Condition? (G/P)	Good

Possible Solutions:

**Remove & Replace Curb Ramp With Two New Directional Ramps or Equivalent.**

**R304.5.1, R304.2.2**
