# Access Compliance Report

## Public Rights-of-Way

### (Curb Ramps)

Intersection ID: 16139	Main Street: BILTMORE_DR	Cross Street: CHEROKEE_RD	Location: SE
ADA ID: 471D3E76D2D1	Ramp Type: Perp	Initial Pass/Fail: Fail	Overall Compliance: No
Severity Score: 12.5			
Codes/Mitigation Info/Possible Solution		Field Measurements/Component Compliance

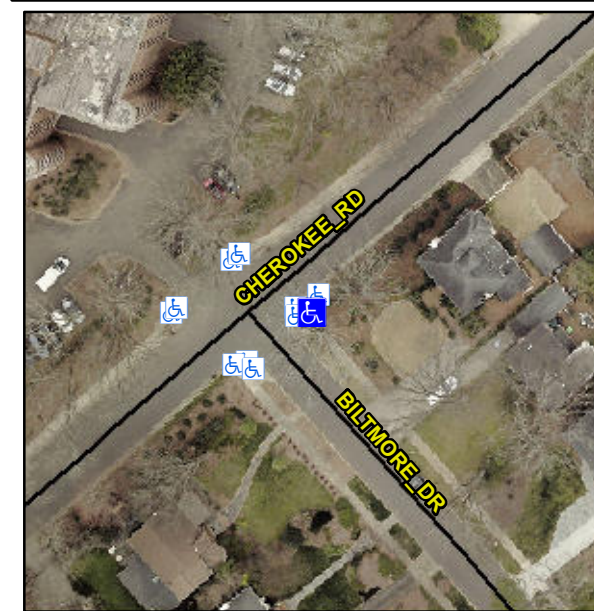
**Not Found, R304.2.2**

Compliance	Description	Data	Compliance	Description	Data
N/A	Ramp Length (in)	92.0	No	Ramp Slope (%)	8.7
Yes	Ramp Width (in)	58.0	Yes	Ramp XSlope (%)	0.5
N/A	Flare Type LT	N/A	N/A	Flare Type RT	N/A
N/A	Flare Slope LT (%)	N/A	N/A	Flare Slope RT (%)	N/A
N/A	Flare Traversable LT?	N/A	N/A	Flare Traversable RT?	N/A
N/A	Landing Length (in)	N/A	N/A	DWS Provided?	N/A
N/A	Landing Width (in)	N/A	N/A	DWS Contrast?	N/A
N/A	Landing Slope (%)	N/A	N/A	DWS Length (in)	N/A
N/A	Landing X Slope (%)	N/A	N/A	DWS Full Width?	N/A
N/A	Landing Curb? (Y/N)	N/A	N/A	DWS Offset (in)	N/A
N/A	Shared Landing?	N/A			
N/A	Gutter Ponding?	N/A	N/A	Gutter Slope (%)	N/A
N/A	Gutter Lip Ht (in)	N/A	N/A	Gutter X Slope (%)	N/A
N/A	Painted X Walk1?	No	N/A	Painted X Walk2?	N/A
	X Walk 1 Direction	To SW		X Walk 2 Direction	N/A
N/A	X Walk 1 Width (in)	N/A	N/A	X Walk 2 Width (in)	N/A
	X Walk 1 Slope (%)	1.4		X Walk 2 Slope (%)	N/A
	X Walk 1 X Slope (%)	2.1		X Walk 2 X Slope (%)	N/A

Possible Solutions:

**Remove & Replace Entire Ramp.**
