# Access Compliance Report

## Public Rights-of-Way

| Intersection ID: 15682 | Main Street: GREEN_FOREST_DR | Cross Street: REDDMAN_RD | Location: NE |
| ADA ID: 4720FBD0C278 | Ramp Type: PerpDiag | Initial Pass/Fail: Fail | Overall Compliance: No |

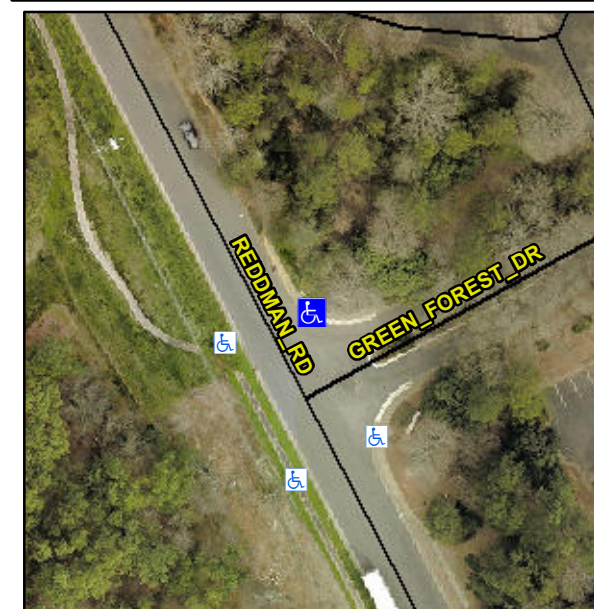
**R304.5.1, R304.2.2, R304.5.3**

| Compliance | Description | Data | Compliance | Description | Data |
|---|---|---|---|---|---|
| N/A | Ramp Length (in) | 49.0 | No | Ramp Slope (%) | 15.4 |
| No | Ramp Width (in) | 39.0 | No | Ramp XSlope (%) | 2.8 |
| N/A | Gutter Ponding? | Yes | N/A | Gutter Slope (%) | N/A |

**Remove & Replace Curb Ramp With Two New Directional Ramps or Equivalent.**

Total Cost: \$ 3200.00
