## **Access Compliance Report Public Rights-of-Way** (Curb Ramps)

Intersection ID: 21514 Main Street: E ARROWOOD RD **Cross Street: NATIONS FORD RD** Location: SE ADA ID: 473BAB812526 Ramp Type: BlendTrans2 Initial Pass/Fail: Fail **Overall Compliance: No Severity Score:** 12.5

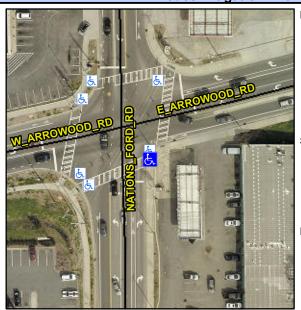
| N/A | Ramp Length (in) | 104.0 | Yes | BlendTrans Slope (%) | 2.1 |
|---|---|---|---|---|---|
| Yes | Ramp Width (in) | 53.0 | No | BlendTrans XSlope (%) | 5.6 |

**NATIONS FORD RD** Street 1 Name Stop Condition-Street 1 Signal Street 2 Name N/A Stop Condition-Street 2 N/A Possible Solutions: Remove & Replace Curb Ramp With Two New Directional Ramps or Equivalent. Surveyor Notes: N/A PROW/ADA: R304.5.3
