# Access Compliance Report

## Public Rights-of-Way

### (Curb Ramps)

Intersection ID: 52246	Main Street: CENTERLINE_DR	Cross Street: KNOX_FARM_RD	Location: SE
ADA ID: 474E6F4B88B9	Ramp Type: Perp	Initial Pass/Fail: Fail	Overall Compliance: No
Severity Score: 22.5			
Codes/Mitigation Info/Possible Solution		Field Measurements/Component Compliance

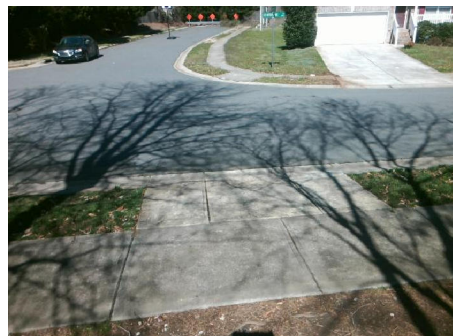
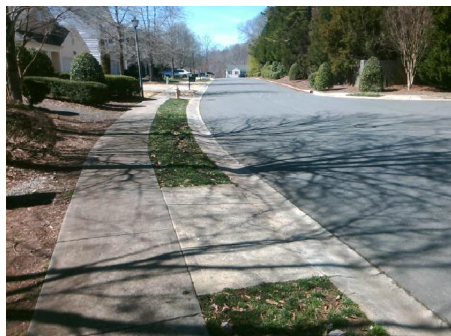
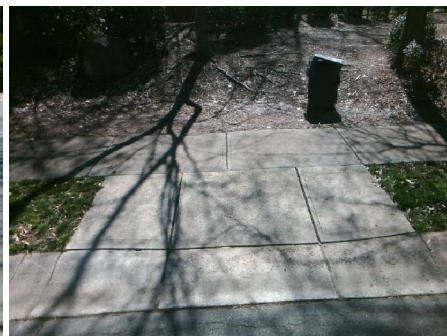
Compliance	Description	Data	Compliance	Description	Data
N/A	Ramp Length (in)	47.0	No	Ramp Slope (%)	9.5
No	Ramp Width (in)	47.5	No	Ramp XSlope (%)	2.6
N/A	Flare Type LT	N/A	N/A	Flare Type RT	N/A
N/A	Flare Slope LT (%)	N/A	N/A	Flare Slope RT (%)	N/A
N/A	Flare Traversable LT?	N/A	N/A	Flare Traversable RT?	N/A
N/A	Landing Length (in)	N/A	N/A	DWS Provided?	N/A
N/A	Landing Width (in)	N/A	N/A	DWS Contrast?	N/A
N/A	Landing Slope (%)	N/A	N/A	DWS Length (in)	N/A
N/A	Landing X Slope (%)	N/A	N/A	DWS Full Width?	N/A
N/A	Landing Curb? (Y/N)	N/A	N/A	DWS Offset (in)	N/A
N/A	Shared Landing?	N/A			
N/A	Gutter Ponding?	N/A	N/A	Gutter Slope (%)	N/A
N/A	Gutter Lip Ht (in)	N/A	N/A	Gutter X Slope (%)	N/A
N/A	Painted X Walk1?	No	N/A	Painted X Walk2?	N/A
	X Walk 1 Direction	To N		X Walk 2 Direction	N/A
N/A	X Walk 1 Width (in)	N/A	N/A	X Walk 2 Width (in)	N/A
	X Walk 1 Slope (%)	3.4		X Walk 2 Slope (%)	N/A
	X Walk 1 X Slope (%)	2.0		X Walk 2 X Slope (%)	N/A

N/A	Ramp inside XWalk1?	N/A	N/A	Ramp inside XWalk2?	N/A
	Road Slope (%)	N/A	N/A	Clear Space?	N/A
	Road X Slope (%)	N/A	N/A	Clear Space to XWalk (in)	N/A
N/A	Any Obstructions?	N/A	N/A	Storm Grate/Utility Hazard?	N/A
	Obstruction Type			Storm Grate/Utility Type	
		N/A			N/A
			Yes	Surface Condition? (G/P)	Good

**Remove & Replace Entire Ramp.**
