# Access Compliance Report

## Public Rights-of-Way

### (Curb Ramps)

Intersection ID: 8020	Main Street: AUSTIN_DR	Cross Street: DAWN_CR	Location: SW
ADA ID: 4751BFB48B00	Ramp Type: Perp	Initial Pass/Fail: Fail	Overall Compliance: No Severity Score: 13.75

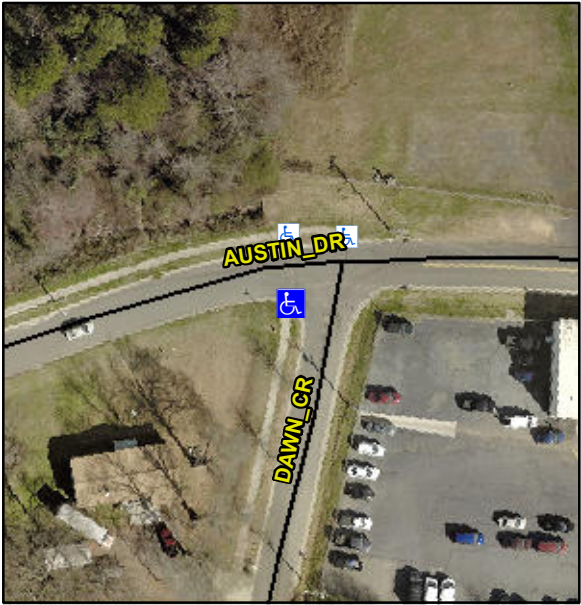
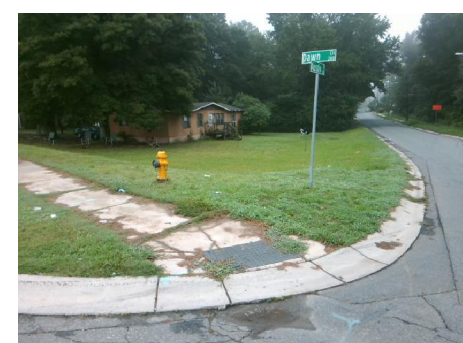
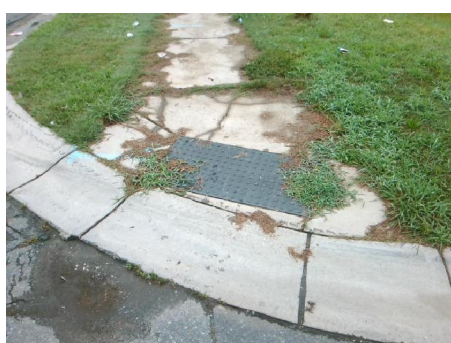
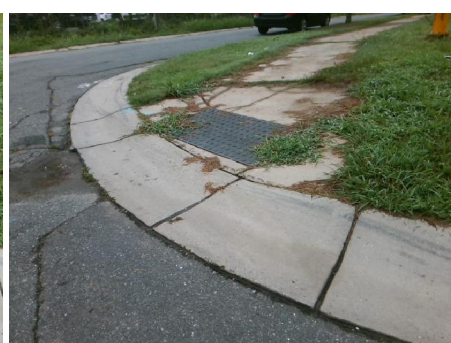
Possible Solutions:		<b>Compliance</b>	<b>Description</b>	<b>Data</b>
	Remove & Replace Entire Ramp.		N/A	Ramp Length (in)	60.0
			Yes	Ramp Width (in)	48.0
			N/A	Flare Type LT	N/A
			N/A	Flare Slope LT (%)	N/A
			N/A	Flare Traversable LT?	N/A
			N/A	Landing Length (in)	N/A
			N/A	Landing Width (in)	N/A
			N/A	Landing Slope (%)	N/A
			N/A	Landing X Slope (%)	N/A
<p>Surveyor Notes:</p> <p>N/A</p> <p>PROW/ADA:</p> <p>Not Found, R304.2.2</p>			N/A	Flare Type RT	N/A
			N/A	Flare Slope RT (%)	N/A
			N/A	Flare Traversable RT?	N/A
			N/A	DWS Provided?	N/A
			N/A	DWS Contrast?	N/A
			N/A	DWS Length (in)	N/A
			N/A	DWS Full Width?	N/A
			N/A	DWS Offset (in)	N/A
			N/A	Gutter Ponding?	N/A
			N/A	Gutter Lip Ht (in)	1.5
			N/A	Painted X Walk1?	No
				X Walk 1 Direction	To NW
			N/A	X Walk 1 Width (in)	N/A
				X Walk 1 Slope (%)	5.7
				X Walk 1 X Slope (%)	3.4

N/A	Ramp inside XWalk1?	N/A
				Road Slope (%)	N/A
				Road X Slope (%)	N/A
			N/A	Any Obstructions?	N/A
				Obstruction Type	
Total Cost: \$ 1850.00			N/A	Storm Grate/Utility Hazard?	N/A
				Storm Grate/Utility Type	
			N/A		N/A
			Yes	Surface Condition? (G/P)	Good
