# Access Compliance Report

## Public Rights-of-Way

### (Curb Ramps)

Intersection ID: 44001	Main Street: ELROSE_PL	Cross Street: N/A	Location: SE
ADA ID: 4762123F23C3	Ramp Type: Perp	Initial Pass/Fail: Fail	Overall Compliance: No
Severity Score: 22.5			
Codes/Mitigation Info/Possible Solution		Field Measurements/Component Compliance

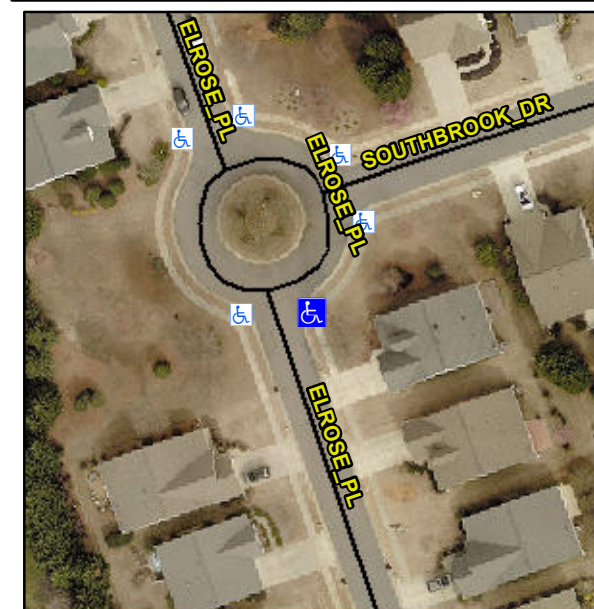
**Not Found, R304.5.1, R304.2.2, R304.5.3**

Compliance	Description	Data	Compliance	Description	Data
N/A	Ramp Length (in)	44.0	No	Ramp Slope (%)	9.0
No	Ramp Width (in)	44.0	No	Ramp XSlope (%)	4.7
N/A	Flare Type LT	N/A	N/A	Flare Type RT	N/A
N/A	Flare Slope LT (%)	N/A	N/A	Flare Slope RT (%)	N/A
N/A	Flare Traversable LT?	N/A	N/A	Flare Traversable RT?	N/A
N/A	Landing Length (in)	N/A	N/A	DWS Provided?	N/A
N/A	Landing Width (in)	N/A	N/A	DWS Contrast?	N/A
N/A	Landing Slope (%)	N/A	N/A	DWS Length (in)	N/A
N/A	Landing X Slope (%)	N/A	N/A	DWS Full Width?	N/A
N/A	Landing Curb? (Y/N)	N/A	N/A	DWS Offset (in)	N/A
N/A	Shared Landing?	N/A			
N/A	Gutter Ponding?	N/A	N/A	Gutter Slope (%)	N/A
N/A	Gutter Lip Ht (in)	N/A	N/A	Gutter X Slope (%)	N/A
N/A	Painted X Walk1?	No	N/A	Painted X Walk2?	N/A
	X Walk 1 Direction	To W		X Walk 2 Direction	N/A
N/A	X Walk 1 Width (in)	N/A	N/A	X Walk 2 Width (in)	N/A
	X Walk 1 Slope (%)	2.4		X Walk 2 Slope (%)	N/A
	X Walk 1 X Slope (%)	4.7		X Walk 2 X Slope (%)	N/A

**Remove & Replace Entire Ramp.**

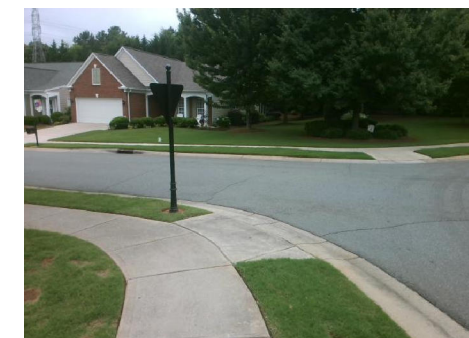
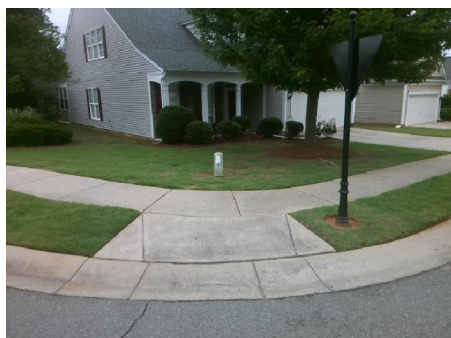
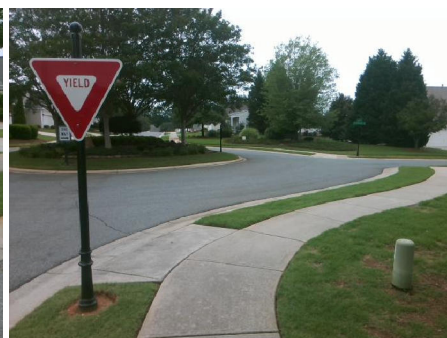
N/A	Ramp inside XWalk1?	N/A	N/A	Ramp inside XWalk2?	N/A
	Road Slope (%)	N/A	N/A	Clear Space?	N/A
	Road X Slope (%)	N/A	N/A	Clear Space to XWalk (in)	N/A
N/A	Any Obstructions?	N/A	N/A	Storm Grate/Utility Hazard?	N/A
	Obstruction Type			Storm Grate/Utility Type	
		N/A			N/A
			Yes	Surface Condition? (G/P)	Good
