Access Compliance Report

Public Rights-of-Way

(Curb Ramps)

Intersection ID: 43653	Main Street: HUNTINGTON_MEADOW_LN	Cross Street: TAGGERT_TRAIL_DR	Location: SW
ADA ID: 476660BF9789	Ramp Type: Perp	Initial Pass/Fail: Fail	Overall Compliance: No
Severity Score: 12.5			
Codes/Mitigation Info/Possible Solution		Field Measurements/Component Compliance

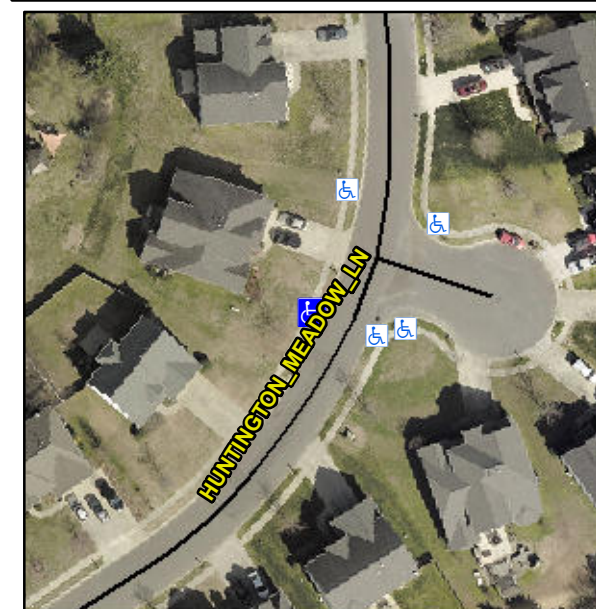
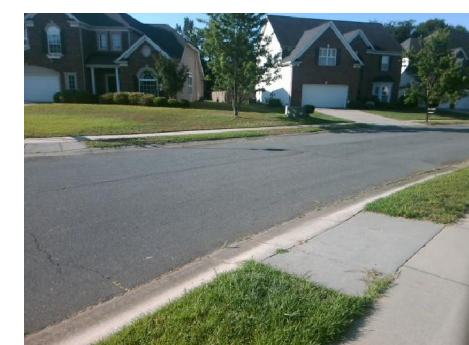
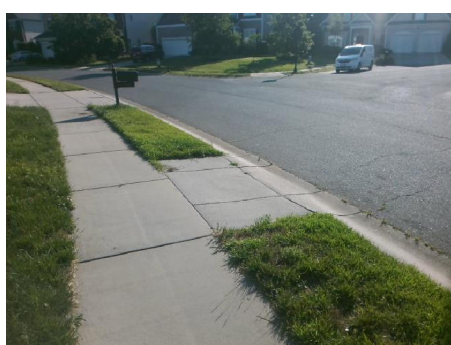
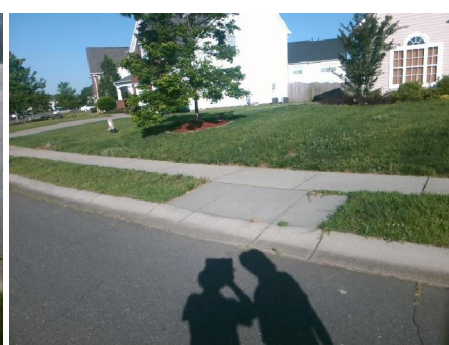
Not Found, R304.2.2

Compliance	Description	Data	Compliance	Description	Data
N/A	Ramp Length (in)	46.0	No	Ramp Slope (%)	11.3
Yes	Ramp Width (in)	49.5	Yes	Ramp XSlope (%)	0.9
N/A	Flare Type LT	N/A	N/A	Flare Type RT	N/A
N/A	Flare Slope LT (%)	N/A	N/A	Flare Slope RT (%)	N/A
N/A	Flare Traversable LT?	N/A	N/A	Flare Traversable RT?	N/A
N/A	Landing Length (in)	N/A	N/A	DWS Provided?	N/A
N/A	Landing Width (in)	N/A	N/A	DWS Contrast?	N/A
N/A	Landing Slope (%)	N/A	N/A	DWS Length (in)	N/A
N/A	Landing X Slope (%)	N/A	N/A	DWS Full Width?	N/A
N/A	Landing Curb? (Y/N)	N/A	N/A	DWS Offset (in)	N/A
N/A	Shared Landing?	N/A			
N/A	Gutter Ponding?	N/A	N/A	Gutter Slope (%)	N/A
N/A	Gutter Lip Ht (in)	N/A	N/A	Gutter X Slope (%)	N/A
N/A	Painted X Walk1?	No	N/A	Painted X Walk2?	N/A
	X Walk 1 Direction	To E		X Walk 2 Direction	N/A
N/A	X Walk 1 Width (in)	N/A	N/A	X Walk 2 Width (in)	N/A
	X Walk 1 Slope (%)	1.6		X Walk 2 Slope (%)	N/A
	X Walk 1 X Slope (%)	0.8		X Walk 2 X Slope (%)	N/A

N/A	Ramp inside XWalk1?	N/A	N/A	Ramp inside XWalk2?	N/A
	Road Slope (%)	N/A	N/A	Clear Space?	N/A
	Road X Slope (%)	N/A	N/A	Clear Space to XWalk (in)	N/A
N/A	Any Obstructions?	N/A	N/A	Storm Grate/Utility Hazard?	N/A
	Obstruction Type			Storm Grate/Utility Type	
		N/A			N/A
			Yes	Surface Condition? (G/P)	Good

Possible Solutions:

Remove & Replace Entire Ramp.

Total Cost: \$ 1850.00
