# Access Compliance Report

## Public Rights-of-Way

### (Curb Ramps)

Intersection ID: 49131	Main Street: EWERT_CUT_LN	Cross Street: WILTSHIRE_RIDGE_RD	Location:	N
ADA ID: 476C1487D60D	Ramp Type: Perp	Initial Pass/Fail: Fail	Overall Compliance: No	Severity Score: 12.5
Codes/Mitigation Info/Possible Solution		Field Measurements/Component Compliance

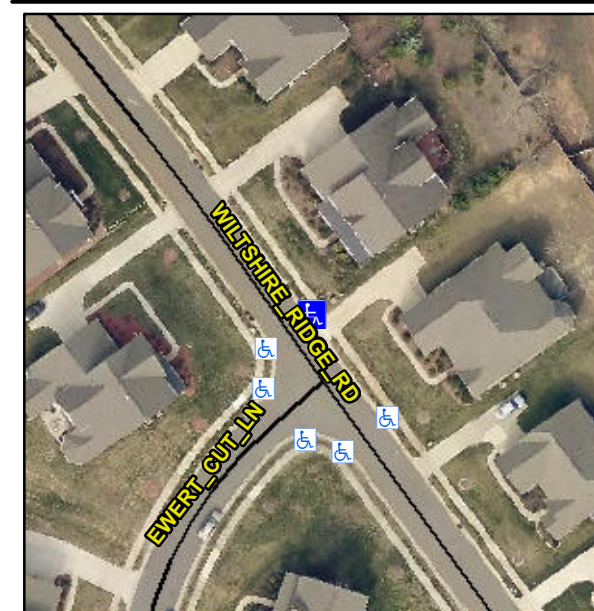
**Not Found, R304.5.3**

Compliance	Description	Data	Compliance	Description	Data
N/A	Ramp Length (in)	47.5	Yes	Ramp Slope (%)	5.9
Yes	Ramp Width (in)	49.0	No	Ramp XSlope (%)	5.7
N/A	Flare Type LT	N/A	N/A	Flare Type RT	N/A
N/A	Flare Slope LT (%)	N/A	N/A	Flare Slope RT (%)	N/A
N/A	Flare Traversable LT?	N/A	N/A	Flare Traversable RT?	N/A
N/A	Landing Length (in)	N/A	N/A	DWS Provided?	N/A
N/A	Landing Width (in)	N/A	N/A	DWS Contrast?	N/A
N/A	Landing Slope (%)	N/A	N/A	DWS Length (in)	N/A
N/A	Landing X Slope (%)	N/A	N/A	DWS Full Width?	N/A
N/A	Landing Curb? (Y/N)	N/A	N/A	DWS Offset (in)	N/A
N/A	Shared Landing?	N/A			
N/A	Gutter Ponding?	N/A	N/A	Gutter Slope (%)	N/A
N/A	Gutter Lip Ht (in)	N/A	N/A	Gutter X Slope (%)	N/A
N/A	Painted X Walk1?	No	N/A	Painted X Walk2?	N/A
	X Walk 1 Direction	To SW		X Walk 2 Direction	N/A
N/A	X Walk 1 Width (in)	N/A	N/A	X Walk 2 Width (in)	N/A
	X Walk 1 Slope (%)	5.3		X Walk 2 Slope (%)	N/A
	X Walk 1 X Slope (%)	7.8		X Walk 2 X Slope (%)	N/A

N/A	Ramp inside XWalk1?	N/A	N/A	Ramp inside XWalk2?	N/A
	Road Slope (%)	N/A	N/A	Clear Space?	N/A
	Road X Slope (%)	N/A	N/A	Clear Space to XWalk (in)	N/A
N/A	Any Obstructions?	N/A	N/A	Storm Grate/Utility Hazard?	N/A
	Obstruction Type			Storm Grate/Utility Type	
		N/A			N/A
			Yes	Surface Condition? (G/P)	Good

Possible Solutions:

**Remove & Replace Entire Ramp.**

Total Cost: \$ 1850.00
