Access Compliance Report

Public Rights-of-Way

(Curb Ramps)

Intersection ID: N/A	Main Street: BALLANTYNE_VILLAGE_DR	Cross Street: N/A	Location: NW
ADA ID: 476EABDEA36A	Ramp Type: Perp	Initial Pass/Fail: Fail	Overall Compliance: No
Codes/Mitigation Info/Possible Solution			Severity Score: 25
			Field Measurements/Component Compliance

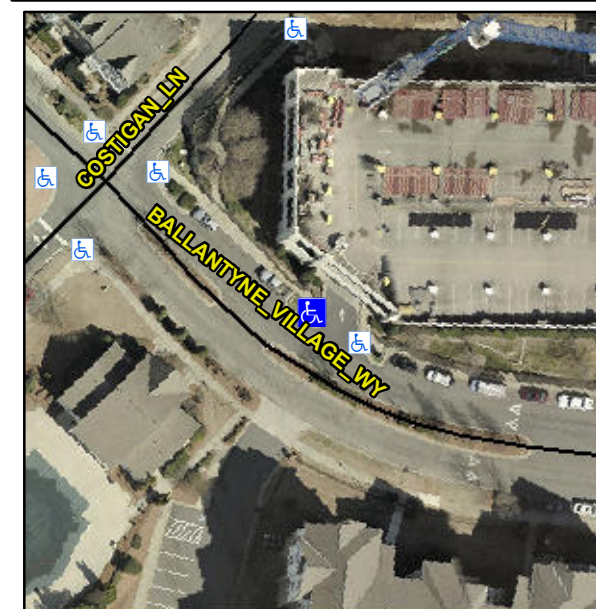
Not Found, R304.5.3

Compliance	Description	Data	Compliance	Description	Data
N/A	Ramp Length (in)	80.0	Yes	Ramp Slope (%)	6.5
Yes	Ramp Width (in)	48.0	No	Ramp XSlope (%)	8.7
N/A	Flare Type LT	N/A	N/A	Flare Type RT	N/A
N/A	Flare Slope LT (%)	N/A	N/A	Flare Slope RT (%)	N/A
N/A	Flare Traversable LT?	N/A	N/A	Flare Traversable RT?	N/A
N/A	Landing Length (in)	N/A	N/A	DWS Provided?	N/A
N/A	Landing Width (in)	N/A	N/A	DWS Contrast?	N/A
N/A	Landing Slope (%)	N/A	N/A	DWS Length (in)	N/A
N/A	Landing X Slope (%)	N/A	N/A	DWS Full Width?	N/A
N/A	Landing Curb? (Y/N)	N/A	N/A	DWS Offset (in)	N/A
N/A	Shared Landing?	N/A			
N/A	Gutter Ponding?	N/A	N/A	Gutter Slope (%)	N/A
N/A	Gutter Lip Ht (in)	N/A	N/A	Gutter X Slope (%)	N/A
N/A	Painted X Walk1?	No	N/A	Painted X Walk2?	N/A
	X Walk 1 Direction	To SE		X Walk 2 Direction	N/A
N/A	X Walk 1 Width (in)	N/A	N/A	X Walk 2 Width (in)	N/A
	X Walk 1 Slope (%)	1.2		X Walk 2 Slope (%)	N/A
	X Walk 1 X Slope (%)	9.9		X Walk 2 X Slope (%)	N/A

Remove & Replace Entire Ramp.

Total Cost: \$ 1850.00
