## Access Compliance Report Public Rights-of-Way (Curb Ramps)

Intersection ID: N/A	Main Str	reet: PROVIDENCE_RD	Cross Street	Cross Street: N/A				NW	
ADA ID: 477DEEAF360C	Ramp Ty	ype: PerpDiag	nitial Pass/Fail: Pass Overall Compliance: No				o Severity Score:	2.75	
Codes/Mitigation Info/Possible Solution				Field Measurements/Component Compliance

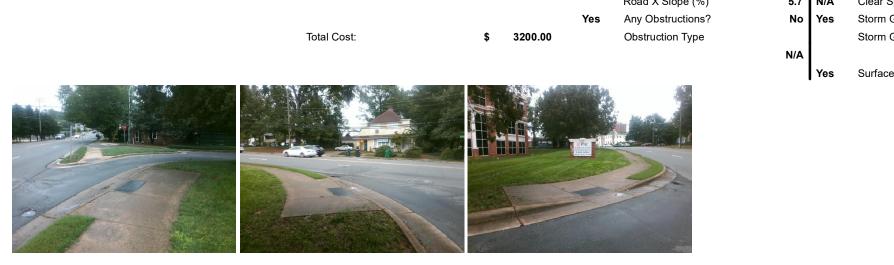
6.	A CARLER OF	Possible Solutions:	Com	Compliance Description		Data Compliance Description		Data	
		Remove & Replace Curb Ramp With Two New Directional Ramps or Equivalent.	ith N/A	Ramp Length (in)	43.5	Yes	Ramp Slope (%)	7.3	
			Yes	Ramp Width (in)	51.0	No	Ramp XSlope (%)	2.4	
			N/A	Flare Type LT	Sloped	N/A	Flare Type RT	N/A	
			N/A	Flare Slope LT (%)	8.3	Yes	Flare Slope RT (%)	6.6	
the state of the state of the			N/A	Flare Traversable LT?	Yes	N/A	Flare Traversable RT?	Yes	
			No	Landing Length (in)	44.0	Yes	DWS Provided?	Yes

t.		Surveyor Notes:	Yes	Landing Width (in)	50.0	Yes	DWS Contrast?	Yes	
		N/A	No	Landing Slope (%)	3.6	Yes	DWS Length (in)	24.0	
			Yes	Landing X Slope (%)	0.4	No	DWS Full Width?	No	
			N/A	Landing Curb? (Y/N)		No	DWS Offset (in)	3.5	
		1	N/A	Shared Landing?	No		( )		
		PROW/ADA:	Yes	Gutter Ponding?	No	Yes	Gutter Slope (%)	1.6

G. Statistics of the		Not Found, R304.5.3, R304.2.1,	Yes	Gutter Lip Ht (in)	0.0	Yes	Gutter X Slope (%)	0.9	
		R304.2.2-Perp, R304.3.2-Para,	N/A	Painted X Walk1?	No		Painted X Walk2?	No	
		R305.1.4, R305.2		X Walk 1 Direction	To S		X Walk 2 Direction	To E	
			N/A	X Walk 1 Width (in)	N/A	N/A	X Walk 2 Width (in)	N/A	
Street 1 Name	ENTRANCE			X Walk 1 Slope (%)	3.1		X Walk 2 Slope (%)	5.3	
Stop Condition-Street 2	StopSign			X Walk 1 X Slope (%)	5.1		X Walk 2 X Slope (%)	2.0	
Street 2 Name	PROVIDENCE RD		N/A	Ramp inside XWalk1?	N/A	N/A	Ramp inside XWalk2?	2.0 N/A	
Stop Condition-Street 1	None			Road Slope (%)	0.1	N/A	Clear Space?	Yes	
	None			Road X Slope (%)	5.7	N/A	Clear Space to XWalk (in)	N/A	
			Yes	Any Obstructions?	5.7 No		Storm Grate/Utility Hazard?	N/A No	
		Total Cost: \$ 32	00.00	Obstruction Type	NU	103	Storm Grate/Utility Type	NO
