Access Compliance Report

Public Rights-of-Way

(Curb Ramps)

Intersection ID: N/A	Main Street: STEEL_CREEK_RD	Cross Street: SHOPTON_RD	Location: S
ADA ID: 4787FA75D865	Ramp Type: Perp	Initial Pass/Fail: Fail	Overall Compliance: No
Codes/Mitigation Info/Possible Solution		Field Measurements/Component Compliance	
Severity Score: 10

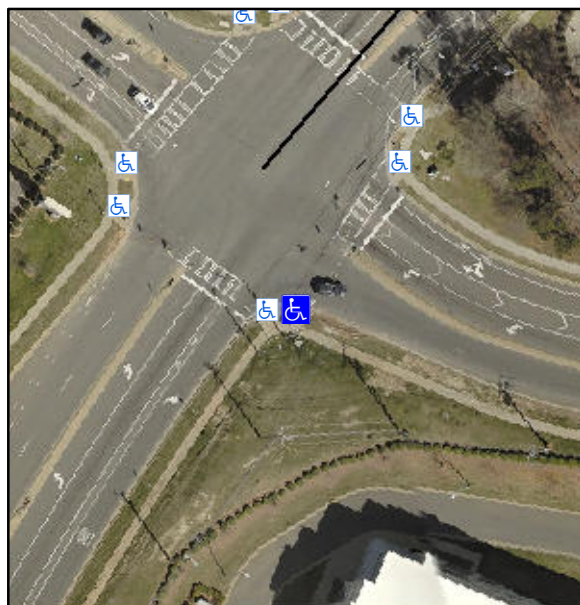
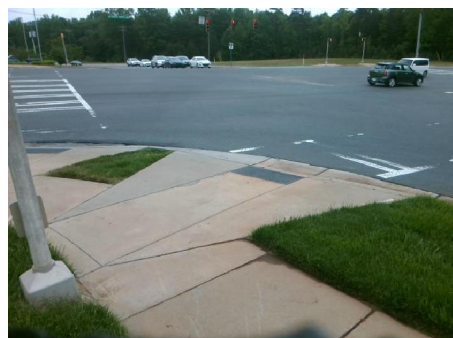
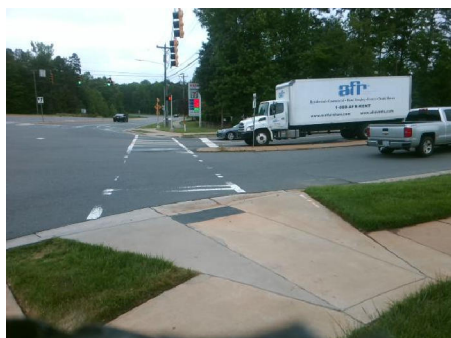
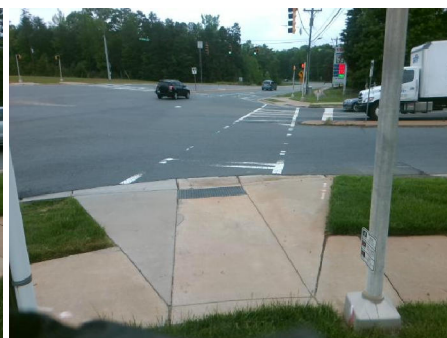
Not Found, R304.5.1, R304.5.3

Compliance	Description	Data	Compliance	Description	Data
N/A	Ramp Length (in)	94.0	Yes	Ramp Slope (%)	5.5
No	Ramp Width (in)	47.0	No	Ramp XSlope (%)	4.6
N/A	Flare Type LT	N/A	N/A	Flare Type RT	N/A
N/A	Flare Slope LT (%)	N/A	N/A	Flare Slope RT (%)	N/A
N/A	Flare Traversable LT?	N/A	N/A	Flare Traversable RT?	N/A
N/A	Landing Length (in)	N/A	N/A	DWS Provided?	N/A
N/A	Landing Width (in)	N/A	N/A	DWS Contrast?	N/A
N/A	Landing Slope (%)	N/A	N/A	DWS Length (in)	N/A
N/A	Landing X Slope (%)	N/A	N/A	DWS Full Width?	N/A
N/A	Landing Curb? (Y/N)	N/A	N/A	DWS Offset (in)	N/A
N/A	Shared Landing?	N/A			
N/A	Gutter Ponding?	N/A	N/A	Gutter Slope (%)	N/A
N/A	Gutter Lip Ht (in)	N/A	N/A	Gutter X Slope (%)	N/A
N/A	Painted X Walk1?	Yes	N/A	Painted X Walk2?	N/A
	X Walk 1 Direction	To NE		X Walk 2 Direction	N/A
N/A	X Walk 1 Width (in)	109.0	N/A	X Walk 2 Width (in)	N/A
	X Walk 1 Slope (%)	1.9		X Walk 2 Slope (%)	N/A
	X Walk 1 X Slope (%)	1.2		X Walk 2 X Slope (%)	N/A

N/A	Ramp inside XWalk1?	Yes	N/A	Ramp inside XWalk2?	N/A
	Road Slope (%)	N/A	N/A	Clear Space?	N/A
	Road X Slope (%)	N/A	N/A	Clear Space to XWalk (in)	N/A
N/A	Any Obstructions?	N/A	N/A	Storm Grate/Utility Hazard?	N/A
	Obstruction Type			Storm Grate/Utility Type	
		N/A			N/A
		Yes		Surface Condition? (G/P)	Good

Remove & Replace Entire Ramp.
