# Access Compliance Report

## Public Rights-of-Way

### (Curb Ramps)

Intersection ID: 1003387	Main Street: ROYAL_BLUFF_DR	Cross Street: N/A	Location: NE
ADA ID: 478DE76A2FD5	Ramp Type: Perp	Initial Pass/Fail: Fail	Overall Compliance: No
Severity Score: 21.25			
Codes/Mitigation Info/Possible Solution		Field Measurements/Component Compliance

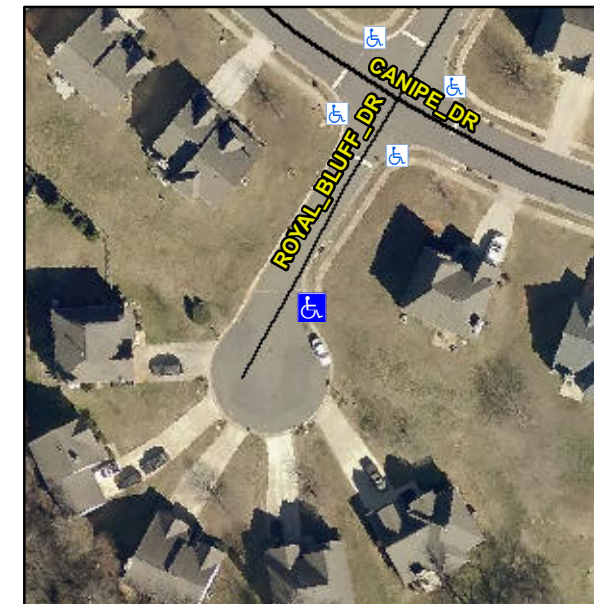
Compliance	Description	Data	Compliance	Description	Data
N/A	Ramp Length (in)	49.5	Yes	Ramp Slope (%)	7.6
No	Ramp Width (in)	47.2	No	Ramp XSlope (%)	5.4
N/A	Flare Type LT	N/A	N/A	Flare Type RT	N/A
N/A	Flare Slope LT (%)	N/A	N/A	Flare Slope RT (%)	N/A
N/A	Flare Traversable LT?	N/A	N/A	Flare Traversable RT?	N/A
N/A	Landing Length (in)	N/A	N/A	DWS Provided?	N/A
N/A	Landing Width (in)	N/A	N/A	DWS Contrast?	N/A
N/A	Landing Slope (%)	N/A	N/A	DWS Length (in)	N/A
N/A	Landing X Slope (%)	N/A	N/A	DWS Full Width?	N/A
N/A	Landing Curb? (Y/N)	N/A	N/A	DWS Offset (in)	N/A
N/A	Shared Landing?	N/A			
N/A	Gutter Ponding?	N/A	N/A	Gutter Slope (%)	N/A
N/A	Gutter Lip Ht (in)	N/A	N/A	Gutter X Slope (%)	N/A
N/A	Painted X Walk1?	No	N/A	Painted X Walk2?	N/A
	X Walk 1 Direction	To SW		X Walk 2 Direction	N/A
N/A	X Walk 1 Width (in)	N/A	N/A	X Walk 2 Width (in)	N/A
	X Walk 1 Slope (%)	4.6		X Walk 2 Slope (%)	N/A
	X Walk 1 X Slope (%)	0.2		X Walk 2 X Slope (%)	N/A

**Remove & Replace Entire Ramp.**

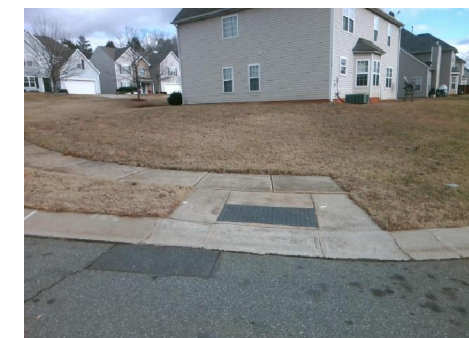
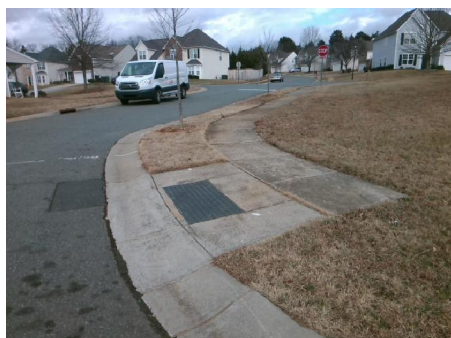
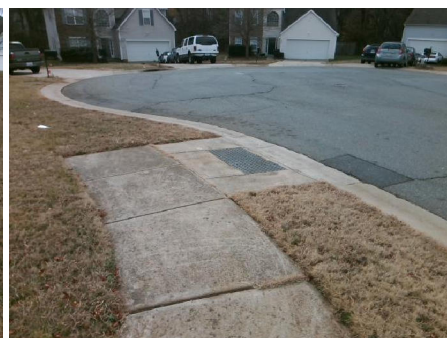
**Not Found, R304.5.1, R304.5.3**

N/A	Ramp inside XWalk1?	N/A	N/A	Ramp inside XWalk2?	N/A
	Road Slope (%)	N/A	N/A	Clear Space?	N/A
	Road X Slope (%)	N/A	N/A	Clear Space to XWalk (in)	N/A
N/A	Any Obstructions?	N/A	N/A	Storm Grate/Utility Hazard?	N/A
	Obstruction Type			Storm Grate/Utility Type	
		N/A			N/A
			Yes	Surface Condition? (G/P)	Good

Total Cost: \$ 1850.00
