Access Compliance Report

Public Rights-of-Way

(Curb Ramps)

| Intersection ID: 54217 | Main Street: GOLF_LINKS_DR | Cross Street: MIDWAY_PARK_DR | Location: SE |

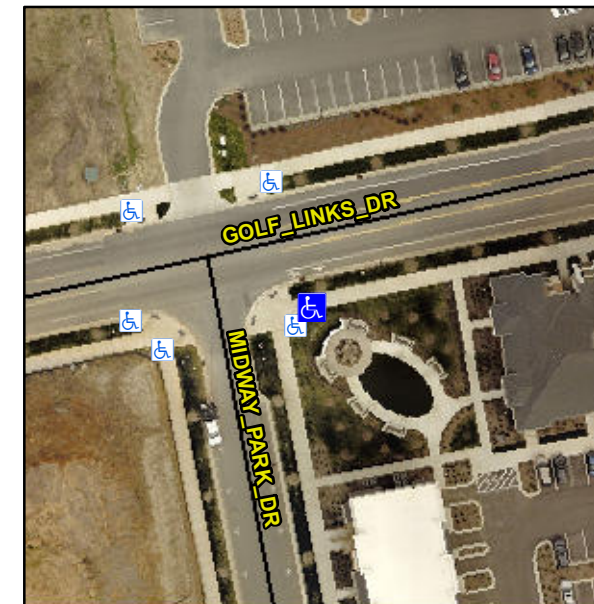
| ADA ID: 4791FFDD906F | Ramp Type: Perp | Initial Pass/Fail: Fail | Overall Compliance: No |

Not Found, R304.5.3

| Compliance | Description | Data | Compliance | Description | Data |
|---|---|---|---|---|---|
| Yes | Ramp Width (in) | 61.0 | No | Ramp XSlope (%) | 5.5 |

Possible Solutions:

Remove & Replace Entire Ramp.
