Access Compliance Report Public Rights-of-Way (Curb Ramps)

Intersection ID: 30383 Main Street: BELLSOUTH_DR Cross Street: CENTRAL_AV Location: W **Overall Compliance: No** ADA ID: 4793D7E3E925 Ramp Type: Perp Initial Pass/Fail: Fail **Severity Score:** 8.75

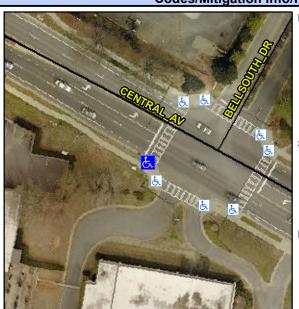
Field Measurements/Component Compliance								
Compl	iance Description	Data	Compl	iance	Description	Data		
N/A	Ramp Length (in)	60.5	Yes	Ramp	Slope (%)	7.4		
No	Ramp Width (in)	47.0	Yes	Ramp	XSlope (%)	1.7		
N/A	Flare Type LT	N/A	N/A	Flare	Type RT	N/A		
N/A	Flare Slope LT (%)	N/A	N/A	Flare	Slope RT (%)	N/A		
N/A	Flare Traversable LT?	N/A	N/A	Flare	Traversable RT?	N/A		
N/A	Landing Length (in)	N/A	N/A	DWS	Provided?	N/A		
N/A	Landing Width (in)	N/A	N/A	DWS	Contrast?	N/A		
N/A	Landing Slope (%)	N/A	N/A	DWS	Length (in)	N/A		
N/A	Landing X Slope (%)	N/A	N/A	DWS	Full Width?	N/A		
N/A	Landing Curb? (Y/N)	N/A	N/A	DWS	Offset (in)	N/A		
N/A	Shared Landing?	N/A						
N/A	Gutter Ponding?	N/A	N/A	Gutte	r Slope (%)	N/A		
N/A	Gutter Lip Ht (in)	N/A	N/A	Gutte	r X Slope (%)	N/A		
N/A	Painted X Walk1?	Yes	N/A	Paint	ed X Walk2?	N/A		
	X Walk 1 Direction	To NE		X Wa	lk 2 Direction	N/A		
N/A	X Walk 1 Width (in)	110.0	N/A	X Wa	lk 2 Width (in)	N/A

X Walk 1 Slope (%)	0.4		X Wa	lk 2 Slope (%)	N/A		
	X Walk 1 X Slope (%)	1.4		X Wa	lk 2 X Slope (%)	N/A		
N/A	Ramp inside XWalk1?	Yes	N/A	Ramp	inside XWalk2?	N/A		
	Road Slope (%)	N/A	N/A	Clear	Space?	N/A		
	Road X Slope (%)	N/A	N/A	Clear	Space to XWalk (in)	N/A		
N/A	Any Obstructions?	N/A	N/A	Storm	n Grate/Utility Hazard?	N/A		
	Obstruction Type			Storm	n Grate/Utility Type			
		N/A				N/A		
			Yes	Surfa	ce Condition? (G/P)	Good

0001810 001811011	
Possible Solutions:	Cor
Remove & Replace Entire Ramp.	N/A
·	No
	N/A
	N/A
	N/A
	N/A
Surveyor Notes:	N/A
N/A	N/A
	N/A
	N/A
	N/A
PROW/ADA:	N/A
Not Found, R304.5.1	N/A
	N/A
	N/A
	N/A

Total Cost:	\$	1850.00
