## Access Compliance Report Public Rights-of-Way (Curb Ramps)

Intersection ID: 31877 Main Street: WILLIAMS\_GLENN\_RD Cross Street: SANDY\_PORTER\_RD Location: SW

ADA ID: 4794F17461D3 Ramp Type: PerpDiag Initial Pass/Fail: Fail Overall Compliance: No Severity Score: 21.25

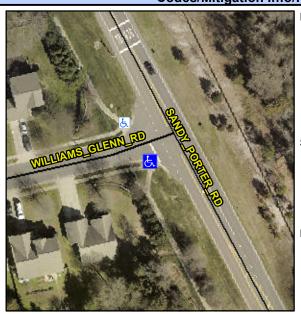
Not Found, R304.5.1, R304.5.3

| Field Measurements/Component Compilance | | | | | |
|---|---|---|---|---|---|
| N/A | Ramp Length (in) | 96.0 | Yes | Ramp Slope (%) | 7.6 |
| No | Ramp Width (in) | 37.0 | No | Ramp XSlope (%) | 5.9 |

Remove & Replace Curb Ramp With Two New Directional Ramps or Equivalent.
