# Access Compliance Report

## Public Rights-of-Way

### (Curb Ramps)

| Intersection ID: 31585 | Main Street: NAPTON_CT | Cross Street: PATTONSBURG_DR | Location: NE |

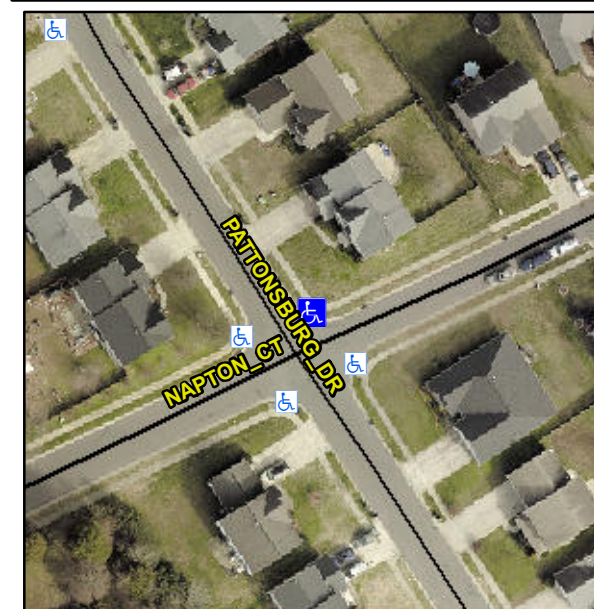
| ADA ID: 479C2778B19C | Ramp Type: PerpDiag | Initial Pass/Fail: Fail | Overall Compliance: No |
| Severity Score: 8.75 | | | |

**Not Found, R304.5.1**

| Compliance | Description | Data | Compliance | Description | Data |
|---|---|---|---|---|---|
| N/A | Ramp Length (in) | 52.0 | Yes | Ramp Slope (%) | 5.2 |
| No | Ramp Width (in) | 37.5 | Yes | Ramp XSlope (%) | 1.5 |

**Remove & Replace Curb Ramp With Two New Directional Ramps or Equivalent.**

Total Cost: \$ 3200.00
