Access Compliance Report Public Rights-of-Way (Curb Ramps)

Intersection ID: 29361 Main Street: REALTREE_LN Cross Street: SUMMIT_HILLS_DR Location: SE

ADA ID: 479FDCB72336 Ramp Type: PerpDiag Initial Pass/Fail: Fail Overall Compliance: No Severity Score: 21.25

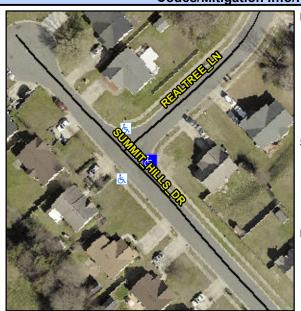
Not Found, R304.5.1, R304.5.3

i icia incusui cincitts/Gomponent Gomphanec						
	Compliance Description		Data	Compli	iance Description	Data
	N/A	Ramp Length (in)	47.5	Yes	Ramp Slope (%)	5.0
	No	Ramp Width (in)	44.0	No	Ramp XSlope (%)	5.5
	N/A	Flare Type LT	N/A	N/A	Flare Type RT	N/A
	N/A	Flare Slope LT (%)	N/A	N/A	Flare Slope RT (%)	N/A
	N/A	Flare Traversable LT?	N/A	N/A	Flare Traversable RT?	N/A
	N/A	Landing Length (in)	N/A	N/A	DWS Provided?	N/A
	N/A	Landing Width (in)	N/A	N/A	DWS Contrast?	N/A
	N/A	Landing Slope (%)	N/A	N/A	DWS Length (in)	N/A
	N/A	Landing X Slope (%)	N/A	N/A	DWS Full Width?	N/A
	N/A	Landing Curb? (Y/N)	N/A	N/A	DWS Offset (in)	N/A
	N/A	Shared Landing?	N/A			
	N/A	Gutter Ponding?	N/A	N/A	Gutter Slope (%)	N/A
	N/A	Gutter Lip Ht (in)	N/A	N/A	Gutter X Slope (%)	N/A
	N/A	Painted X Walk1?	No	N/A	Painted X Walk2?	No
		X Walk 1 Direction	To N		X Walk 2 Direction	To W
	N/A	X Walk 1 Width (in)	N/A	N/A	X Walk 2 Width (in)	N/A
		X Walk 1 Slope (%)	0.6		X Walk 2 Slope (%)	6.3

X Walk 1 X Slope (%)	5.6		X Walk 2 X Slope (%)	1.1
	N/A	Ramp inside XWalk1?	N/A	N/A	Ramp inside XWalk2?	N/A
		Road Slope (%)	3.5	N/A	Clear Space?	N/A
		Road X Slope (%)	3.4	N/A	Clear Space to XWalk (in)	N/A
	N/A	Any Obstructions?	N/A	N/A	Storm Grate/Utility Hazard?	N/A
		Obstruction Type			Storm Grate/Utility Type

Remove & Replace Curb Ramp With
Two New Directional Ramps or
Equivalent.
