# Access Compliance Report

## Public Rights-of-Way

| Intersection ID: 11209 | Main Street: W_10TH_ST | Cross Street: N_SMITH_ST | Location: S |
| ADA ID: 47A94D0ED76B | Ramp Type: Perp | Initial Pass/Fail: Fail | Overall Compliance: No |

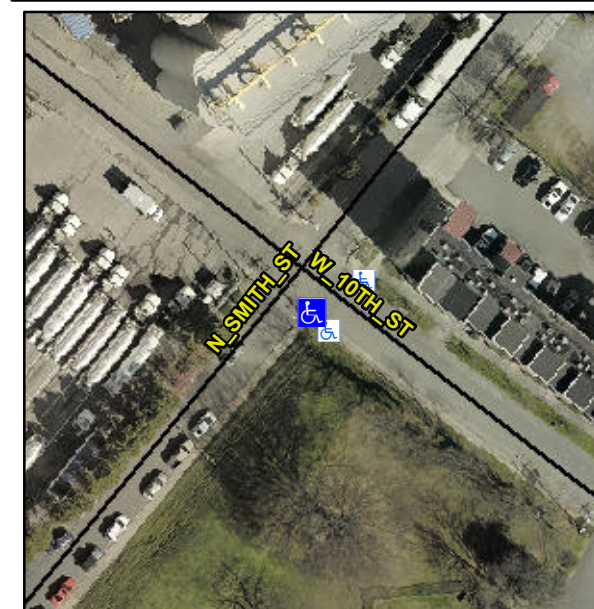
| Severity Score: 41.25 | | | |

**R304.2.2, R304.5.3, R302.7**

| Compliance | Description | Data | Compliance | Description | Data |
|---|---|---|---|---|---|
| N/A | Ramp Length (in) | 45.0 | No | Ramp Slope (%) | 13.3 |
| Yes | Ramp Width (in) | 48.0 | No | Ramp XSlope (%) | 3.3 |
| | | No | | Surface Condition? (G/P) | Poor |

**Remove & Replace Entire Ramp.**

**\$ 1850.00**
