Access Compliance Report

Public Rights-of-Way

(Curb Ramps)

Intersection ID: 8343	Main Street: ATANDO_AV	Cross Street: POINSETT_ST	Location: SE
ADA ID: 47B63929F3B7	Ramp Type: PerpDiag	Initial Pass/Fail: Fail	Overall Compliance: No
Codes/Mitigation Info/Possible Solution		Field Measurements/Component Compliance	
Severity Score: 22.5

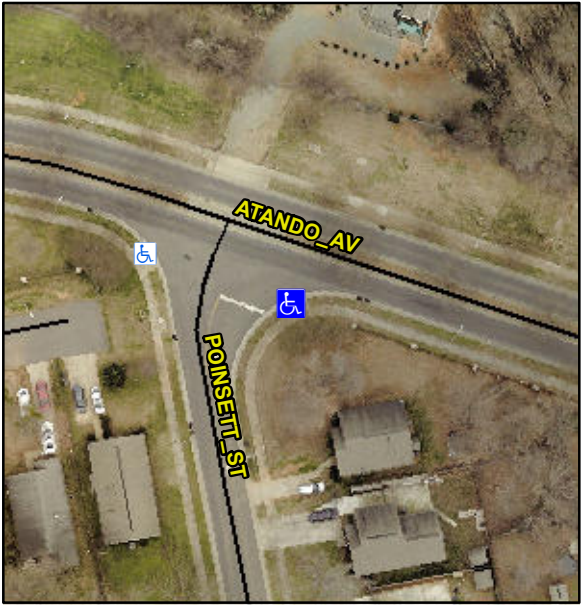
Possible Solutions:	Compliance	Description	Data	Compliance	Description	Data
	Remove & Replace Curb Ramp With Two New Directional Ramps or Equivalent.	N/A	Ramp Length (in)	61.0	No	Ramp Slope (%)	8.5
		No	Ramp Width (in)	42.0	No	Ramp XSlope (%)	3.8
		N/A	Flare Type LT	N/A	N/A	Flare Type RT	N/A
		N/A	Flare Slope LT (%)	N/A	N/A	Flare Slope RT (%)	N/A
		N/A	Flare Traversable LT?	N/A	N/A	Flare Traversable RT?	N/A
		N/A	Landing Length (in)	N/A	N/A	DWS Provided?	N/A
		N/A	Landing Width (in)	N/A	N/A	DWS Contrast?	N/A
		N/A	Landing Slope (%)	N/A	N/A	DWS Length (in)	N/A
		N/A	Landing X Slope (%)	N/A	N/A	DWS Full Width?	N/A
<p>Surveyor Notes:</p> <p>N/A</p> <p>PROW/ADA:</p> <p>R304.5.1, R304.2.2, R304.5.3</p>		N/A	Landing Curb? (Y/N)	N/A	N/A	DWS Offset (in)	N/A
		N/A	Shared Landing?	N/A			
		N/A	Gutter Ponding?	N/A	N/A	Gutter Slope (%)	N/A
		N/A	Gutter Lip Ht (in)	N/A	N/A	Gutter X Slope (%)	N/A
		N/A	Painted X Walk1?	No	N/A	Painted X Walk2?	No

X Walk 1 Direction	To NE		X Walk 2 Direction	To NW
		N/A	X Walk 1 Width (in)	N/A	N/A	X Walk 2 Width (in)	N/A
			X Walk 1 Slope (%)	3.1		X Walk 2 Slope (%)	3.0
			X Walk 1 X Slope (%)	3.2		X Walk 2 X Slope (%)	3.3
		N/A	Ramp inside XWalk1?	N/A	N/A	Ramp inside XWalk2?	N/A
<p>Street 1 Name</p> <p>Stop Condition-Street 2</p> <p>Street 2 Name</p> <p>Stop Condition-Street 1</p>			Road Slope (%)	4.8	N/A	Clear Space?	N/A
			Road X Slope (%)	0.6	N/A	Clear Space to XWalk (in)	N/A
		N/A	Any Obstructions?	N/A	N/A	Storm Grate/Utility Hazard?	N/A
			Obstruction Type			Storm Grate/Utility Type	
					N/A		N/A
					Yes	Surface Condition? (G/P)	Good
Total Cost:		\$	3200.00
