Access Compliance Report

Public Rights-of-Way

(Curb Ramps)

Intersection ID: 23309	Main Street: BRIDGEWOOD_LN	Cross Street: CARMEL_RD	Location: W
ADA ID: 47B82328DBD5	Ramp Type: PerpDiag	Initial Pass/Fail: Fail	Overall Compliance: No
Codes/Mitigation Info/Possible Solution		Field Measurements/Component Compliance

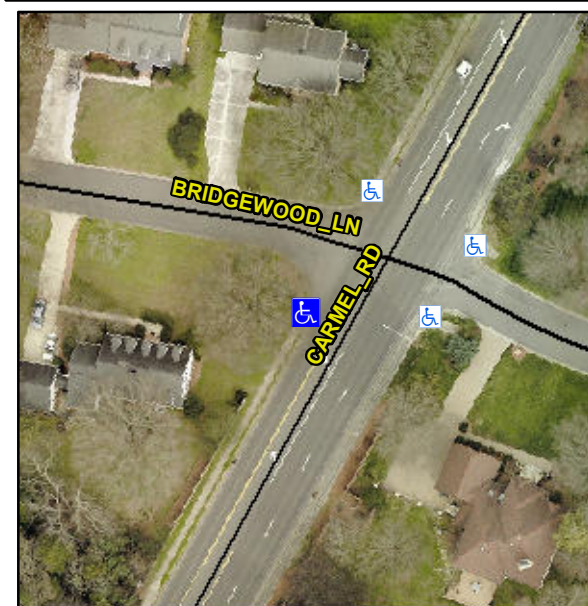
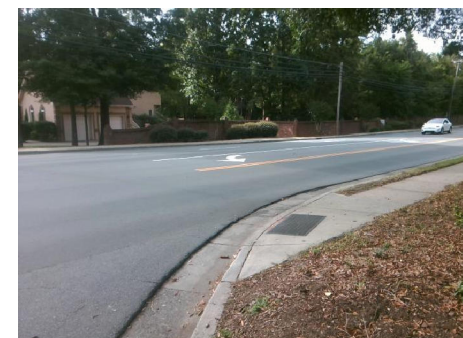
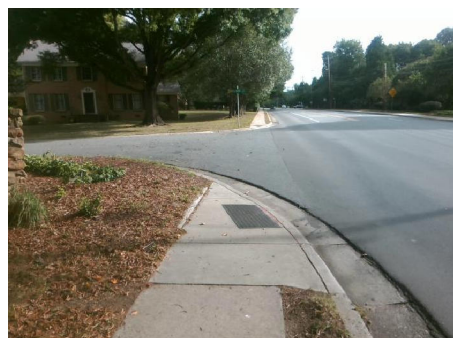
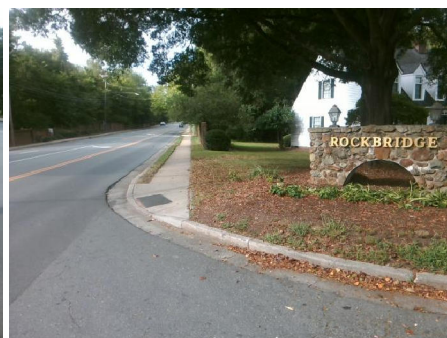
Not Found, R304.2.2, R304.5.3

Compliance	Description	Data	Compliance	Description	Data
N/A	Ramp Length (in)	39.0	No	Ramp Slope (%)	11.4
Yes	Ramp Width (in)	48.0	No	Ramp XSlope (%)	2.8
N/A	Flare Type LT	N/A	N/A	Flare Type RT	N/A
N/A	Flare Slope LT (%)	N/A	N/A	Flare Slope RT (%)	N/A
N/A	Flare Traversable LT?	N/A	N/A	Flare Traversable RT?	N/A
N/A	Landing Length (in)	N/A	N/A	DWS Provided?	N/A
N/A	Landing Width (in)	N/A	N/A	DWS Contrast?	N/A
N/A	Landing Slope (%)	N/A	N/A	DWS Length (in)	N/A
N/A	Landing X Slope (%)	N/A	N/A	DWS Full Width?	N/A
N/A	Landing Curb? (Y/N)	N/A	N/A	DWS Offset (in)	N/A
N/A	Shared Landing?	N/A			
N/A	Gutter Ponding?	N/A	N/A	Gutter Slope (%)	N/A
N/A	Gutter Lip Ht (in)	N/A	N/A	Gutter X Slope (%)	N/A
N/A	Painted X Walk1?	No	N/A	Painted X Walk2?	No
	X Walk 1 Direction	To SE		X Walk 2 Direction	To NE
N/A	X Walk 1 Width (in)	N/A	N/A	X Walk 2 Width (in)	N/A
	X Walk 1 Slope (%)	6.8		X Walk 2 Slope (%)	3.0
	X Walk 1 X Slope (%)	2.1		X Walk 2 X Slope (%)	4.1

N/A	Ramp inside XWalk1?	N/A	N/A	Ramp inside XWalk2?	N/A
	Road Slope (%)	1.2	N/A	Clear Space?	N/A
	Road X Slope (%)	7.3	N/A	Clear Space to XWalk (in)	N/A
N/A	Any Obstructions?	N/A	N/A	Storm Grate/Utility Hazard?	N/A
	Obstruction Type			Storm Grate/Utility Type	
		N/A			N/A
			Yes	Surface Condition? (G/P)	Good

Remove & Replace Curb Ramp With Two New Directional Ramps or Equivalent.
