# Access Compliance Report

## Public Rights-of-Way

### (Curb Ramps)

| Intersection ID: 42359 | Main Street: HERON_GLEN_DR | Cross Street: WRENS_NEST_LN | Location: S |

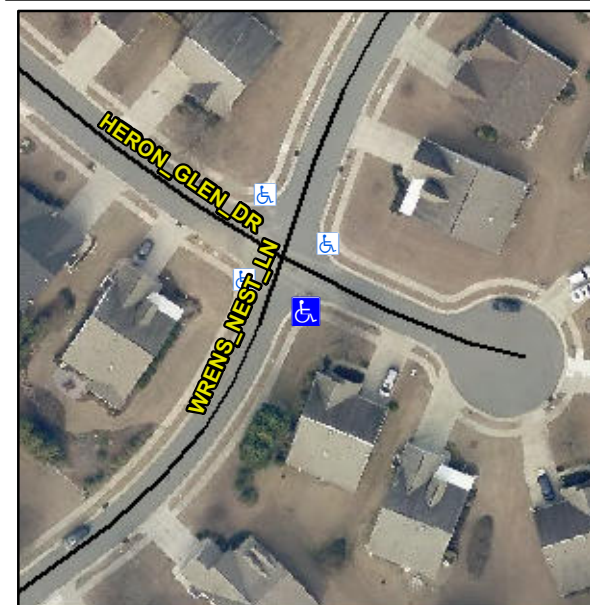
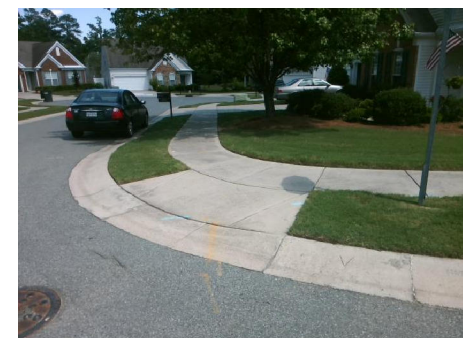
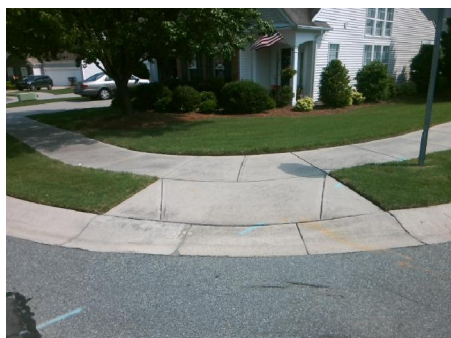
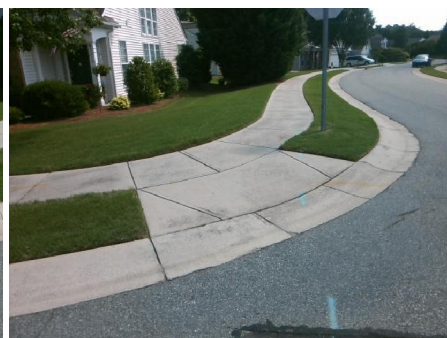
| ADA ID: 47C2DF4066FE | Ramp Type: PerpDiag | Initial Pass/Fail: Pass | Overall Compliance: No |

**Not Found, R304.5.3, R304.2.2-Perp, R304.3.2-Para, R305**

| Compliance | Description | Data | Compliance | Description | Data |
|---|---|---|---|---|---|
| N/A | Ramp Length (in) | 46.0 | Yes | Ramp Slope (%) | 6.1 |
| Yes | Ramp Width (in) | 66.0 | No | Ramp XSlope (%) | 2.7 |
| Yes | Landing Length (in) | 48.0 | No | DWS Provided? | No |
| No | Landing Slope (%) | 3.8 | N/A | DWS Length (in) | N/A |
| No | Landing X Slope (%) | 3.6 | N/A | DWS Full Width? | No |
| Yes | Gutter Lip Ht (in) | 0.0 | No | Gutter X Slope (%) | 2.3 |

**Remove & Replace Curb Ramp With Two New Directional Ramps or Equivalent. Remove & Replace Gutter.**
