Access Compliance Report

Public Rights-of-Way

(Curb Ramps)

Intersection ID: N/A	Main Street: KELBURN_LN	Cross Street: N/A	Location: W
ADA ID: 47CCC759D9CB	Ramp Type: BlendTrans1	Initial Pass/Fail: Fail	Overall Compliance: No
Severity Score: 10			
Codes/Mitigation Info/Possible Solution		Field Measurements/Component Compliance

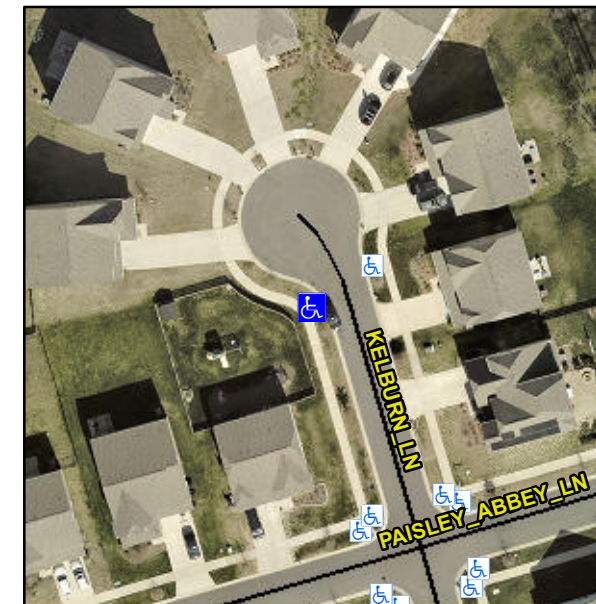
Not Found, R304.5.1, R304.5.3

Compliance	Description	Data	Compliance	Description	Data
N/A	Ramp Length (in)	96.0	Yes	BlendTrans Slope (%)	4.8
No	Ramp Width (in)	45.0	No	BlendTrans XSlope (%)	3.2
N/A	Flare Type LT	N/A	N/A	Flare Type RT	N/A
N/A	Flare Slope LT (%)	N/A	N/A	Flare Slope RT (%)	N/A
N/A	Flare Traversable LT?	N/A	N/A	Flare Traversable RT?	N/A
N/A	Landing Length (in)	N/A	N/A	DWS Provided?	N/A
N/A	Landing Width (in)	N/A	N/A	DWS Contrast?	N/A
N/A	Landing Slope (%)	N/A	N/A	DWS Length (in)	N/A
N/A	Landing X Slope (%)	N/A	N/A	DWS Full Width?	N/A
N/A	Landing Curb? (Y/N)	N/A	N/A	DWS Offset (in)	N/A
N/A	Shared Landing?	N/A			
N/A	Gutter Ponding?	N/A	N/A	Gutter Slope (%)	N/A
N/A	Gutter Lip Ht (in)	N/A	N/A	Gutter X Slope (%)	N/A
N/A	Painted X Walk1?	No	N/A	Painted X Walk2?	N/A
	X Walk 1 Direction	To E		X Walk 2 Direction	N/A
	X Walk 1 Width (in)	N/A		X Walk 2 Width (in)	N/A
	X Walk 1 Slope (%)	2.9		X Walk 2 Slope (%)	N/A
	X Walk 1 X Slope (%)	0.6		X Walk 2 X Slope (%)	N/A

N/A	Ramp inside XWalk1?	N/A	N/A	Ramp inside XWalk2?	N/A
	Road Slope (%)	0.6		Clear Space?	N/A
	Road X Slope (%)	2.9	N/A	Clear Space to XWalk (in)	N/A
N/A	Any Obstructions?	N/A	N/A	Storm Grate/Utility Hazard?	N/A
	Obstruction Type			Storm Grate/Utility Type	
		N/A			N/A
			Yes	Surface Condition? (G/P)	Good
			No	Curb Slope (%)	5.9

Remove & Replace Curb Ramp With Two New Directional Ramps or Equivalent.
