# Access Compliance Report

## Public Rights-of-Way

### (Curb Ramps)

Intersection ID: 3920	Main Street: OVERLOOK_MOUNTAIN_DR	Cross Street: OVERLOOK_COVE_RD	Location: SE
ADA ID: 47D00C89A3E0	Ramp Type: PerpDiag	Initial Pass/Fail: Fail	Overall Compliance: No
Severity Score: 25			
Codes/Mitigation Info/Possible Solution		Field Measurements/Component Compliance

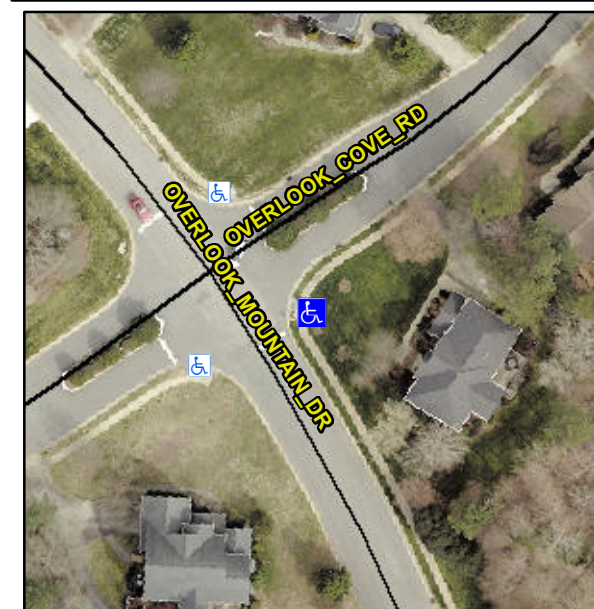
**Not Found, R304.5.3**

Compliance	Description	Data	Compliance	Description	Data
N/A	Ramp Length (in)	47.0	Yes	Ramp Slope (%)	5.9
Yes	Ramp Width (in)	127.0	No	Ramp XSlope (%)	13.0
N/A	Flare Type LT	N/A	N/A	Flare Type RT	N/A
N/A	Flare Slope LT (%)	N/A	N/A	Flare Slope RT (%)	N/A
N/A	Flare Traversable LT?	N/A	N/A	Flare Traversable RT?	N/A
N/A	Landing Length (in)	N/A	N/A	DWS Provided?	N/A
N/A	Landing Width (in)	N/A	N/A	DWS Contrast?	N/A
N/A	Landing Slope (%)	N/A	N/A	DWS Length (in)	N/A
N/A	Landing X Slope (%)	N/A	N/A	DWS Full Width?	N/A
N/A	Landing Curb? (Y/N)	N/A	N/A	DWS Offset (in)	N/A
N/A	Shared Landing?	N/A			
N/A	Gutter Ponding?	N/A	N/A	Gutter Slope (%)	N/A
N/A	Gutter Lip Ht (in)	N/A	N/A	Gutter X Slope (%)	N/A
N/A	Painted X Walk1?	No	N/A	Painted X Walk2?	No
	X Walk 1 Direction	To NW		X Walk 2 Direction	To SW
N/A	X Walk 1 Width (in)	N/A	N/A	X Walk 2 Width (in)	N/A
	X Walk 1 Slope (%)	6.3		X Walk 2 Slope (%)	1.4
	X Walk 1 X Slope (%)	4.9		X Walk 2 X Slope (%)	7.3

N/A	Ramp inside XWalk1?	N/A	N/A	Ramp inside XWalk2?	N/A
	Road Slope (%)	8.0	N/A	Clear Space?	N/A
	Road X Slope (%)	4.3	N/A	Clear Space to XWalk (in)	N/A
N/A	Any Obstructions?	N/A	N/A	Storm Grate/Utility Hazard?	N/A
	Obstruction Type			Storm Grate/Utility Type	
		N/A			N/A
			Yes	Surface Condition? (G/P)	Good

**Remove & Replace Curb Ramp With Two New Directional Ramps or Equivalent.**
