Access Compliance Report

Public Rights-of-Way

(Curb Ramps)

Intersection ID: 14872	Main Street: DILWORTH_RD_EAST	Cross Street: ISLEWORTH_AV	Location: NW
ADA ID: 47D212DC1F0E	Ramp Type: ParaDiag	Initial Pass/Fail: Fail	Overall Compliance: No
Codes/Mitigation Info/Possible Solution		Field Measurements/Component Compliance	
Severity Score: 12.5

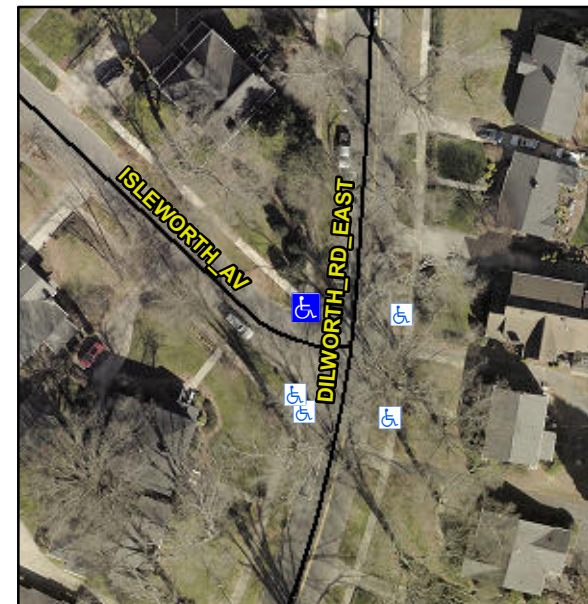
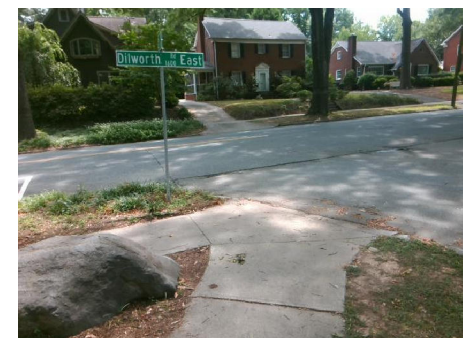
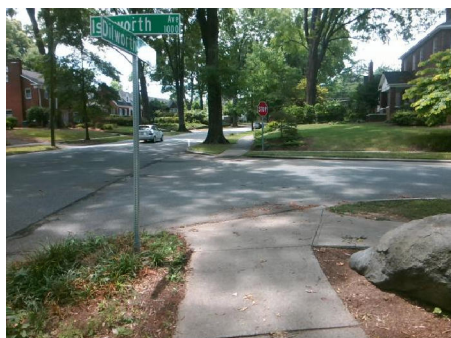
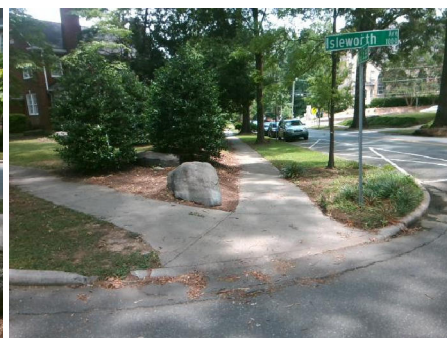
Compliance	Description	Data	Compliance	Description	Data
N/A	Ramp Length LT (in)	51.0	N/A	Ramp Length RT (in)	N/A
Yes	Ramp Width LT (in)	52.0	N/A	Ramp Width RT (in)	N/A
No	Ramp Slope LT (%)	8.6	N/A	Ramp Slope RT (%)	N/A
Yes	Ramp XSlope LT (%)	1.2	N/A	Ramp XSlope RT (%)	N/A
N/A	Landing Length (in)	N/A	N/A	DWS Provided?	N/A
N/A	Landing Width (in)	N/A	N/A	DWS Contrast?	N/A
N/A	Landing Slope (%)	N/A	N/A	DWS Length (in)	N/A
N/A	Landing X Slope (%)	N/A	N/A	DWS Full Width?	N/A
N/A	Landing Curb? (Y/N)	N/A	N/A	DWS Offset (in)	N/A
N/A	Shared Landing?	N/A			
N/A	Gutter Ponding?	N/A	N/A	Gutter Slope (%)	N/A
N/A	Gutter Lip Ht (in)	N/A	N/A	Gutter X Slope (%)	N/A
N/A	Painted X Walk1?	No	N/A	Painted X Walk2?	No
	X Walk 1 Direction	To S		X Walk 2 Direction	To E
N/A	X Walk 1 Width (in)	N/A	N/A	X Walk 2 Width (in)	N/A
	X Walk 1 Slope (%)	2.8		X Walk 2 Slope (%)	1.2
	X Walk 1 X Slope (%)	1.3		X Walk 2 X Slope (%)	3.0
N/A	Ramp inside XWalk1?	N/A	N/A	Ramp inside XWalk2?	N/A

Road Slope (%)	2.3	N/A	Clear Space?	N/A
	Road X Slope (%)	2.5	N/A	Clear Space to XWalk (in)	N/A
N/A	Any Obstructions?	N/A	N/A	Storm Grate/Utility Hazard?	N/A
	Obstruction Type			Storm Grate/Utility Type	
		N/A			N/A
			Yes	Surface Condition? (G/P)	Good
			N/A	Curb Slope (%)	6.4

Possible Solutions:

Remove & Replace Curb Ramp With Two New Directional Ramps or Equivalent.
