Access Compliance Report

Public Rights-of-Way

(Curb Ramps)

Intersection ID: 11815	Main Street: N_POPLAR_ST	Cross Street: W_7TH_ST	Location: S
ADA ID: 47D6091F8EBE	Ramp Type: PerpDiag	Initial Pass/Fail: Fail	Overall Compliance: No
Severity Score: 25			
Codes/Mitigation Info/Possible Solution		Field Measurements/Component Compliance

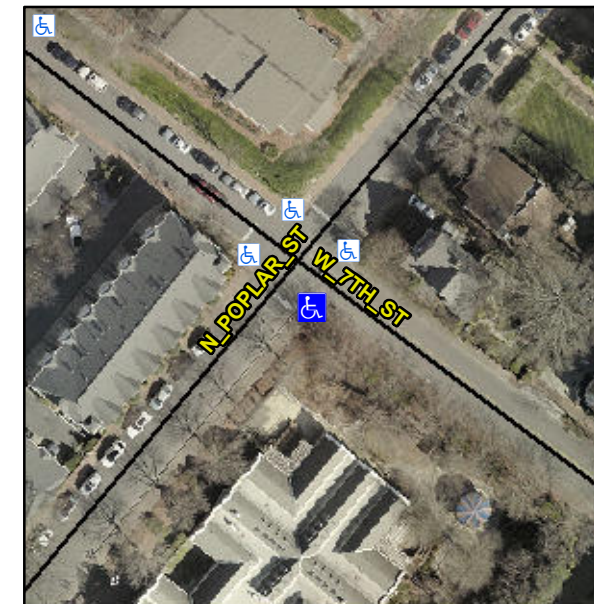
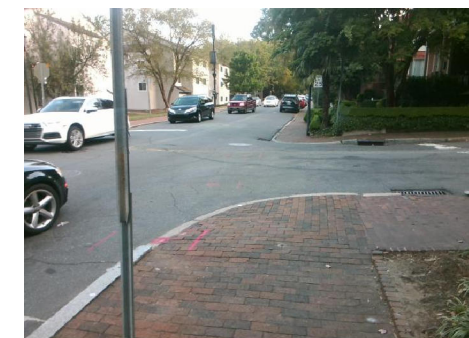
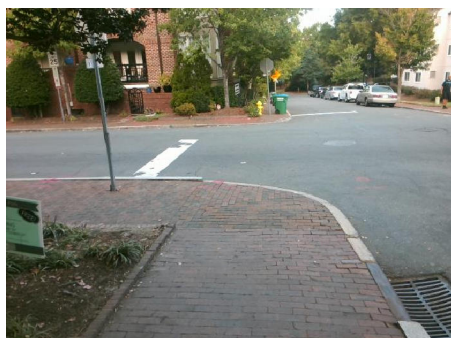
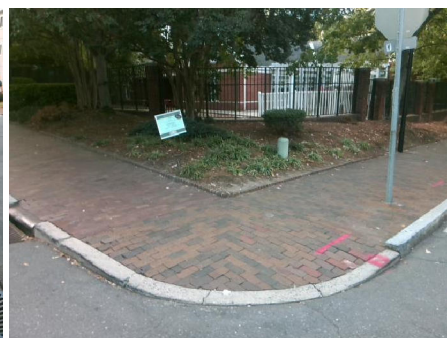
Not Found, R304.2.2, R304.5.3

Compliance	Description	Data	Compliance	Description	Data
N/A	Ramp Length (in)	59.0	No	Ramp Slope (%)	10.7
Yes	Ramp Width (in)	48.0	No	Ramp XSlope (%)	5.8
N/A	Flare Type LT	N/A	N/A	Flare Type RT	N/A
N/A	Flare Slope LT (%)	N/A	N/A	Flare Slope RT (%)	N/A
N/A	Flare Traversable LT?	N/A	N/A	Flare Traversable RT?	N/A
N/A	Landing Length (in)	N/A	N/A	DWS Provided?	N/A
N/A	Landing Width (in)	N/A	N/A	DWS Contrast?	N/A
N/A	Landing Slope (%)	N/A	N/A	DWS Length (in)	N/A
N/A	Landing X Slope (%)	N/A	N/A	DWS Full Width?	N/A
N/A	Landing Curb? (Y/N)	N/A	N/A	DWS Offset (in)	N/A
N/A	Shared Landing?	N/A			
N/A	Gutter Ponding?	N/A	N/A	Gutter Slope (%)	N/A
N/A	Gutter Lip Ht (in)	N/A	N/A	Gutter X Slope (%)	N/A
N/A	Painted X Walk1?	No	N/A	Painted X Walk2?	No
	X Walk 1 Direction	To NE		X Walk 2 Direction	To NW
N/A	X Walk 1 Width (in)	N/A	N/A	X Walk 2 Width (in)	N/A
	X Walk 1 Slope (%)	3.2		X Walk 2 Slope (%)	0.4
	X Walk 1 X Slope (%)	0.7		X Walk 2 X Slope (%)	2.3

N/A	Ramp inside XWalk1?	N/A	N/A	Ramp inside XWalk2?	N/A
	Road Slope (%)	1.2	N/A	Clear Space?	N/A
	Road X Slope (%)	3.0	N/A	Clear Space to XWalk (in)	N/A
N/A	Any Obstructions?	N/A	N/A	Storm Grate/Utility Hazard?	N/A
	Obstruction Type			Storm Grate/Utility Type	
		N/A			N/A
		Yes		Surface Condition? (G/P)	Good

Remove & Replace Curb Ramp With Two New Directional Ramps or Equivalent.
