Access Compliance Report

Public Rights-of-Way

(Curb Ramps)

Intersection ID: 44911	Main Street: FOX_POINT_DR	Cross Street: SPRINGHAVEN_DR	Location:	E
ADA ID: 47DB6FC561E6	Ramp Type: PerpDiag	Initial Pass/Fail: Fail	Overall Compliance: No	Severity Score: 25

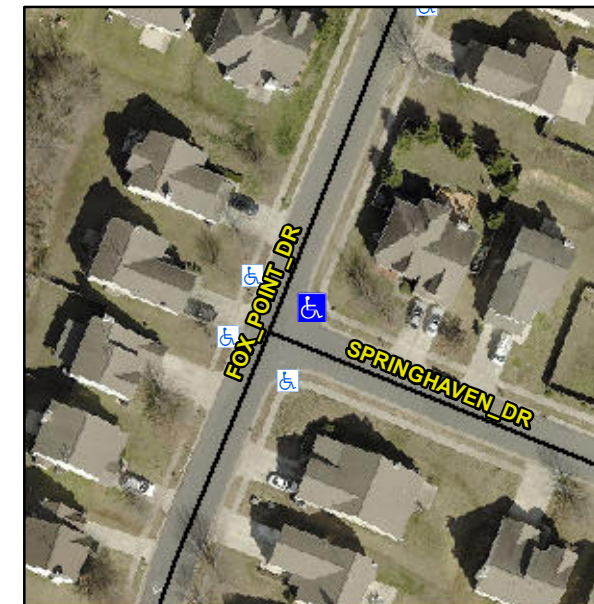
Not Found, R304.5.1, R304.5.3, R302.7

Compliance	Description	Data	Compliance	Description	Data
N/A	Ramp Length (in)	48.0	Yes	Ramp Slope (%)	7.1
No	Ramp Width (in)	40.0	No	Ramp XSlope (%)	4.7
N/A	Flare Type LT	N/A	N/A	Flare Type RT	N/A
N/A	Flare Slope LT (%)	N/A	N/A	Flare Slope RT (%)	N/A
N/A	Flare Traversable LT?	N/A	N/A	Flare Traversable RT?	N/A
N/A	Landing Length (in)	N/A	N/A	DWS Provided?	N/A
N/A	Landing Width (in)	N/A	N/A	DWS Contrast?	N/A
N/A	Landing Slope (%)	N/A	N/A	DWS Length (in)	N/A
N/A	Landing X Slope (%)	N/A	N/A	DWS Full Width?	N/A
N/A	Landing Curb? (Y/N)	N/A	N/A	DWS Offset (in)	N/A
N/A	Shared Landing?	N/A			
N/A	Gutter Ponding?	N/A	N/A	Gutter Slope (%)	N/A
N/A	Gutter Lip Ht (in)	N/A	N/A	Gutter X Slope (%)	N/A
N/A	Painted X Walk1?	No	N/A	Painted X Walk2?	No
	X Walk 1 Direction	To NW		X Walk 2 Direction	To SW
N/A	X Walk 1 Width (in)	N/A	N/A	X Walk 2 Width (in)	N/A
	X Walk 1 Slope (%)	8.8		X Walk 2 Slope (%)	4.3
	X Walk 1 X Slope (%)	2.3		X Walk 2 X Slope (%)	7.4

N/A	Ramp inside XWalk1?	N/A	N/A	Ramp inside XWalk2?	N/A
	Road Slope (%)	4.5	N/A	Clear Space?	N/A
	Road X Slope (%)	7.9	N/A	Clear Space to XWalk (in)	N/A
N/A	Any Obstructions?	N/A	N/A	Storm Grate/Utility Hazard?	N/A
	Obstruction Type			Storm Grate/Utility Type	
		N/A			N/A
		No		Surface Condition? (G/P)	Poor

Remove & Replace Curb Ramp With Two New Directional Ramps or Equivalent.
