## Access Compliance Report Public Rights-of-Way (Curb Ramps)

Intersection ID: 10835Main Street:STATE\_STCross Street:TUCKASEEGE\_RDLocation:NADA ID: 47E8FDFCE3B5Ramp Type:PerpInitial Pass/Fail:FailOverall Compliance:NoSeverity Score:22.5

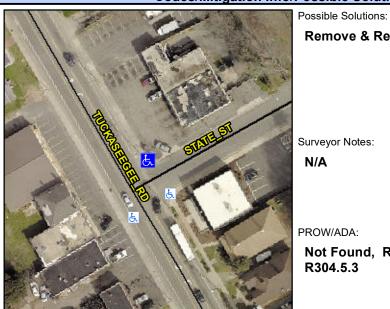
Comp	liance Description	Data	Comp	liance Description	Data
N/A	Ramp Length (in)	59.0	No	Ramp Slope (%)	8.7
No	Ramp Width (in)	47.0	No	Ramp XSlope (%)	3.2
N/A	Flare Type LT	N/A	N/A	Flare Type RT	N/A
N/A	Flare Slope LT (%)	N/A	N/A	Flare Slope RT (%)	N/A
N/A	Flare Traversable LT?	N/A	N/A	Flare Traversable RT?	N/A
N/A	Landing Length (in)	N/A	N/A	DWS Provided?	N/A
N/A	Landing Width (in)	N/A	N/A	DWS Contrast?	N/A
N/A	Landing Slope (%)	N/A	N/A	DWS Length (in)	N/A
N/A	Landing X Slope (%)	N/A	N/A	DWS Full Width?	N/A
N/A	Landing Curb? (Y/N)	N/A	N/A	DWS Offset (in)	N/A
N/A	Shared Landing?	N/A			
N/A	Gutter Ponding?	N/A	N/A	Gutter Slope (%)	N/A
N/A	Gutter Lip Ht (in)	N/A	N/A	Gutter X Slope (%)	N/A
N/A	Painted X Walk1?	No	N/A	Painted X Walk2?	N/A
	X Walk 1 Direction	To S		X Walk 2 Direction	N/A
N/A	X Walk 1 Width (in)	N/A	N/A	X Walk 2 Width (in)	N/A
	X Walk 1 Slope (%)	1.4		X Walk 2 Slope (%)	N/A
	X Walk 1 X Slope (%)	6.8		X Walk 2 X Slope (%)	N/A

N/A	Ramp inside XWalk1?	N/A	N/A	Ramp inside XWalk2?	N/A
	Road Slope (%)	N/A	N/A	Clear Space?	N/A
	Road X Slope (%)	N/A	N/A	Clear Space to XWalk (in)	N/A
N/A	Any Obstructions?	N/A	N/A	Storm Grate/Utility Hazard?	N/A
	Obstruction Type			Storm Grate/Utility Type	
		N/A			N/A
			Yes	Surface Condition? (G/P)	Good

à	
The second	Remove & Replace Entire Ramp.
1	
	Surveyor Notes:
0.000	N/A
į	
i de	PROW/ADA:
	Not Found, R304.5.1, R304.2.2,
	R304.5.3
ě
