Access Compliance Report

Public Rights-of-Way

(Curb Ramps)

Intersection ID: 54454	Main Street: COLLINGHAM_DR	Cross Street: STEELE_CREEK_RD	Location: NW
ADA ID: 47F5B56CE9F2	Ramp Type: Perp	Initial Pass/Fail: Fail	Overall Compliance: No
Severity Score: 26.25			
Codes/Mitigation Info/Possible Solution		Field Measurements/Component Compliance

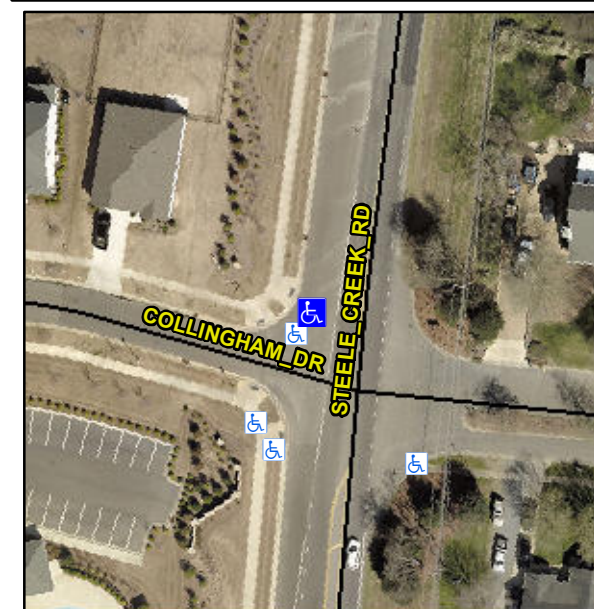
R304.2.2, R304.5.3

Compliance	Description	Data	Compliance	Description	Data
N/A	Ramp Length (in)	96.0	No	Ramp Slope (%)	12.1
Yes	Ramp Width (in)	52.0	No	Ramp XSlope (%)	2.6
N/A	Flare Type LT	N/A	N/A	Flare Type RT	N/A
N/A	Flare Slope LT (%)	N/A	N/A	Flare Slope RT (%)	N/A
N/A	Flare Traversable LT?	N/A	N/A	Flare Traversable RT?	N/A
N/A	Landing Length (in)	N/A	N/A	DWS Provided?	N/A
N/A	Landing Width (in)	N/A	N/A	DWS Contrast?	N/A
N/A	Landing Slope (%)	N/A	N/A	DWS Length (in)	N/A
N/A	Landing X Slope (%)	N/A	N/A	DWS Full Width?	N/A
N/A	Landing Curb? (Y/N)	N/A	N/A	DWS Offset (in)	N/A
N/A	Shared Landing?	N/A			
N/A	Gutter Ponding?	N/A	N/A	Gutter Slope (%)	N/A
N/A	Gutter Lip Ht (in)	N/A	N/A	Gutter X Slope (%)	N/A
N/A	Painted X Walk1?	No	N/A	Painted X Walk2?	N/A
	X Walk 1 Direction	To SE		X Walk 2 Direction	N/A
N/A	X Walk 1 Width (in)	N/A	N/A	X Walk 2 Width (in)	N/A
	X Walk 1 Slope (%)	4.8		X Walk 2 Slope (%)	N/A
	X Walk 1 X Slope (%)	0.8		X Walk 2 X Slope (%)	N/A

Remove & Replace Entire Ramp.

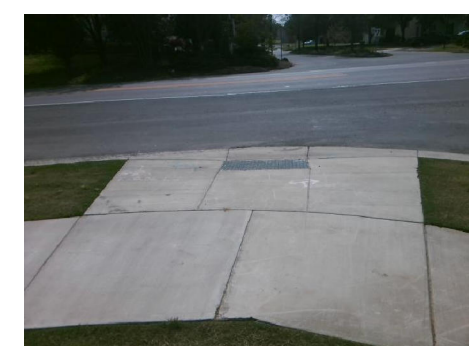
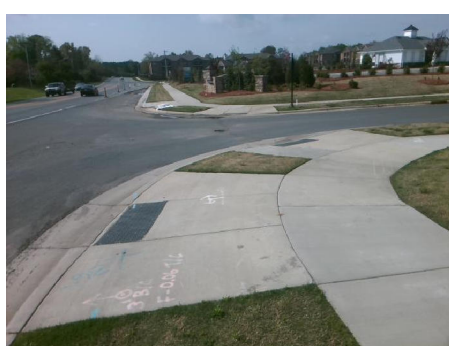
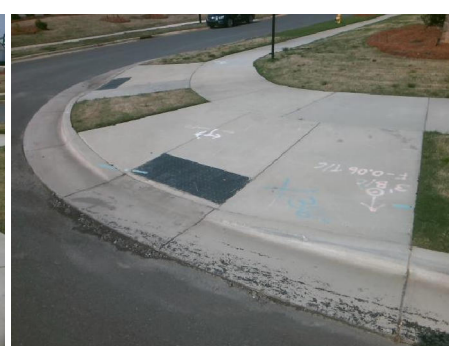
N/A	Ramp inside XWalk1?	N/A	N/A	Ramp inside XWalk2?	N/A
	Road Slope (%)	N/A	N/A	Clear Space?	N/A
	Road X Slope (%)	N/A	N/A	Clear Space to XWalk (in)	N/A
N/A	Any Obstructions?	N/A	N/A	Storm Grate/Utility Hazard?	N/A
	Obstruction Type			Storm Grate/Utility Type	
		N/A			N/A
			Yes	Surface Condition? (G/P)	Good
