Access Compliance Report Public Rights-of-Way (Curb Ramps)

Intersection ID: 14103 Main Street: HARDING PL **Cross Street: BERKELEY_AV** Location: ADA ID: 47FD05576B45 Ramp Type: PerpDiag Initial Pass/Fail: Fail **Overall Compliance: No** Severity Score: 13.75

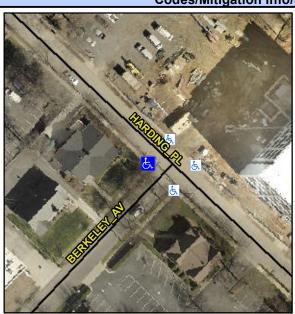
| Field Measurements/Component Compliance | | | | | | | | |
|---|---|---|---|---|---|---|--|--|
| | N/A | Ramp Length (in) | 49.0 | No | Ramp Slope (%) | 9.2 | | |
| | Yes | Ramp Width (in) | 48.0 | No | Ramp XSlope (%) | 3.0 | | |

Possible Solutions: Remove & Replace Curb Ramp With Two New Directional Ramps or Equivalent.

R304.2.2, R304.5.3
