# Access Compliance Report

## Public Rights-of-Way

### (Curb Ramps)

Intersection ID: 14278	Main Street: ROMARE_BEARDEN_DR	Cross Street: FARMER_ST	Location: W
ADA ID: 4807BD980EFD	Ramp Type: MedianPerp	Initial Pass/Fail: Pass	Overall Compliance: No
Severity Score: 12.75			
Codes/Mitigation Info/Possible Solution		Field Measurements/Component Compliance

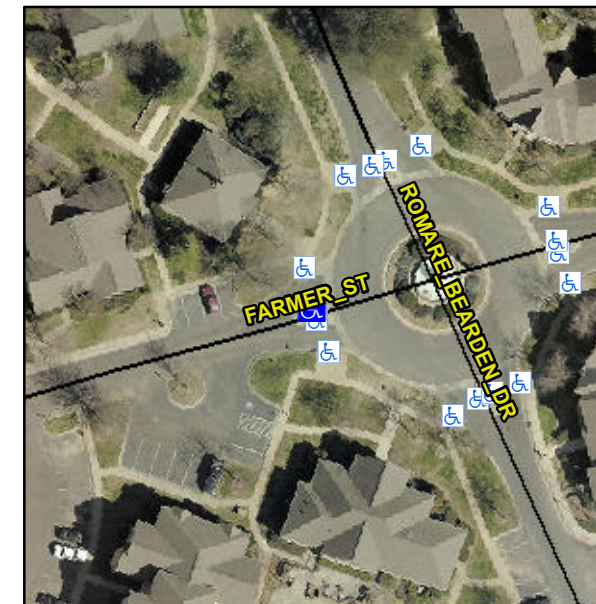
**Not Found, R304.5.3, R304.2.1, R304.2.2-Perp, R304.3.2-Para, R305.1.4, R305.2**

Compliance	Description	Data	Compliance	Description	Data
N/A	Ramp Length (in)	43.0	Yes	Ramp Slope (%)	6.1
Yes	Ramp Width (in)	58.0	No	Ramp XSlope (%)	3.8
N/A	Flare Type LT	Sloped	N/A	Flare Type RT	N/A
N/A	Flare Slope LT (%)	5.8	Yes	Flare Slope RT (%)	6.2
N/A	Flare Traversable LT?	Yes	N/A	Flare Traversable RT?	Yes
No	Landing Length (in)	N/A	Yes	DWS Provided?	Yes
No	Landing Width (in)	N/A	Yes	DWS Contrast?	Yes
No	Landing Slope (%)	N/A	Yes	DWS Length (in)	24.5
No	Landing X Slope (%)	N/A	No	DWS Full Width?	No
N/A	Landing Curb? (Y/N)	N/A	No	DWS Offset (in)	9.0
N/A	Shared Landing?	No			
Yes	Gutter Ponding?	No	Yes	Gutter Slope (%)	3.5
Yes	Gutter Lip Ht (in)	0.0	Yes	Gutter X Slope (%)	1.3
N/A	Painted X Walk1?	No	N/A	Painted X Walk2?	N/A
	X Walk 1 Direction	To N		X Walk 2 Direction	N/A
N/A	X Walk 1 Width (in)	N/A	N/A	X Walk 2 Width (in)	N/A
	X Walk 1 Slope (%)	1.2		X Walk 2 Slope (%)	N/A
	X Walk 1 X Slope (%)	1.3		X Walk 2 X Slope (%)	N/A

N/A	Ramp inside XWalk1?	N/A	N/A	Ramp inside XWalk2?	N/A
	Road Slope (%)	N/A	N/A	Clear Space?	Yes
	Road X Slope (%)	N/A	N/A	Clear Space to XWalk (in)	N/A
Yes	Any Obstructions?	No	Yes	Storm Grate/Utility Hazard?	No
	Obstruction Type			Storm Grate/Utility Type	
		N/A			N/A
			Yes	Surface Condition? (G/P)	Good

**Remove & Replace Entire Ramp.**
