# Access Compliance Report

## Public Rights-of-Way

Intersection ID: 30320	Main Street: EUROSTAR_DR	Cross Street: STOURBRIDGE_LION_DR	Location: S
ADA ID: 480BE17CF4F0	Ramp Type: PerpDiag	Initial Pass/Fail: Fail	Overall Compliance: No
		Severity Score: 35

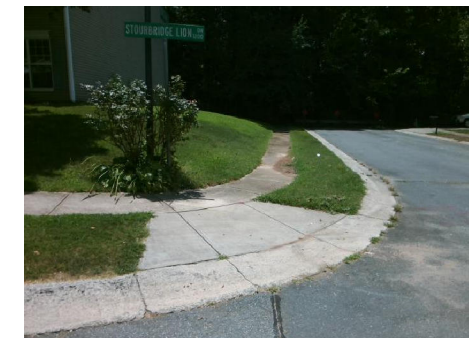
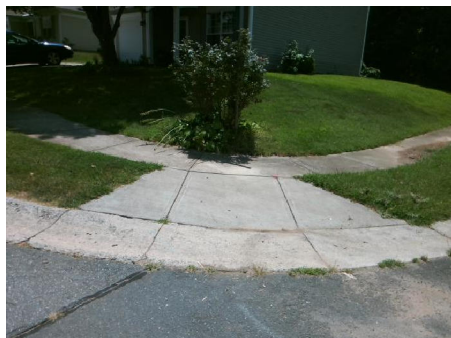
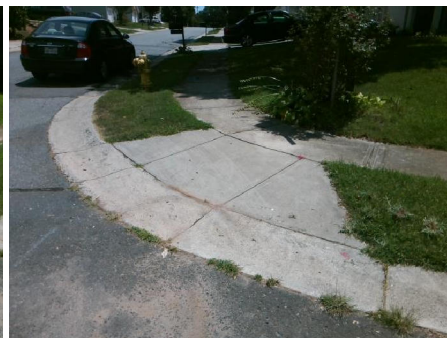
**Not Found, R304.5.1, R304.2.2, R304.5.3**

Compliance	Description	Data	Compliance	Description	Data
N/A	Ramp Length (in)	48.0	No	Ramp Slope (%)	14.3
No	Ramp Width (in)	44.0	No	Ramp XSlope (%)	4.4
N/A	Flare Type LT	N/A	N/A	Flare Type RT	N/A
N/A	Flare Slope LT (%)	N/A	N/A	Flare Slope RT (%)	N/A
N/A	Flare Traversable LT?	N/A	N/A	Flare Traversable RT?	N/A
N/A	Landing Length (in)	N/A	N/A	DWS Provided?	N/A
N/A	Landing Width (in)	N/A	N/A	DWS Contrast?	N/A
N/A	Landing Slope (%)	N/A	N/A	DWS Length (in)	N/A
N/A	Landing X Slope (%)	N/A	N/A	DWS Full Width?	N/A
N/A	Landing Curb? (Y/N)	N/A	N/A	DWS Offset (in)	N/A
N/A	Shared Landing?	N/A			
N/A	Gutter Ponding?	N/A	N/A	Gutter Slope (%)	N/A
N/A	Gutter Lip Ht (in)	N/A	N/A	Gutter X Slope (%)	N/A
N/A	Painted X Walk1?	No	N/A	Painted X Walk2?	No
	X Walk 1 Direction	To E		X Walk 2 Direction	To W
N/A	X Walk 1 Width (in)	N/A	N/A	X Walk 2 Width (in)	N/A
	X Walk 1 Slope (%)	0.4		X Walk 2 Slope (%)	0.0
	X Walk 1 X Slope (%)	5.4		X Walk 2 X Slope (%)	0.7

N/A	Ramp inside XWalk1?	N/A	N/A	Ramp inside XWalk2?	N/A
	Road Slope (%)	2.7	N/A	Clear Space?	N/A
	Road X Slope (%)	3.6	N/A	Clear Space to XWalk (in)	N/A
N/A	Any Obstructions?	N/A	N/A	Storm Grate/Utility Hazard?	N/A
	Obstruction Type			Storm Grate/Utility Type	
		N/A			N/A
			Yes	Surface Condition? (G/P)	Good

**Remove & Replace Curb Ramp With Two New Directional Ramps or Equivalent.**
