## Access Compliance Report Public Rights-of-Way (Curb Ramps)

Intersection ID: 10023486Main Street: CIRCUMFERENTIAL\_RDCross Street: N/ALocation:NWADA ID: 480C9589DDA9Ramp Type: Directional1Initial Pass/Fail: PassOverall Compliance: NoSeverity Score:17.5

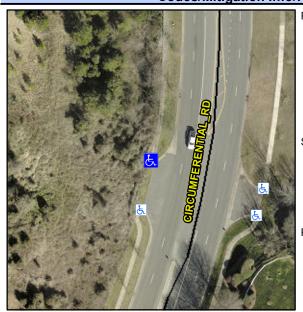
Comp	liance Description	Data	Comp	oliance Description	Data
N/A	Ramp Length (in)	29.0	Yes	Grade Break?	Yes
Yes	Ramp Width (in)	58.0	Yes	Grade Break Slope (%)	0.2
Yes	Ramp Slope (%)	0.2	Yes	Grade Break XSlope (%)	0.8
Yes	Ramp XSlope (%)	0.4			
N/A	Flare Type LT	N/A	N/A	Flare Type RT	N/A
N/A	Flare Slope LT (%)	N/A	N/A	Flare Slope RT (%)	N/A
N/A	Flare Traversable LT?	N/A	N/A	Flare Traversable RT?	N/A
Yes	Landing Length (in)	51.0	Yes	DWS Provided?	Yes
Yes	Landing Width (in)	58.0	Yes	DWS Contrast?	Yes
Yes	Landing Slope (%)	2.0	Yes	DWS Length (in)	24.0
No	Landing X Slope (%)	2.3	No	DWS Full Width?	No
N/A	Landing Curb? (Y/N)	No	Yes	DWS Offset LT (in)	1.0
N/A	Shared Landing?	No	Yes	DWS Offset RT (in)	0.5
Yes	Gutter Ponding?	No	Yes	Gutter Slope (%)	1.2
No	Gutter Lip Ht (in)	1.0	No	Gutter X Slope (%)	2.6
N/A	Painted X Walk1?	No		Road Slope (%)	0.4
	X Walk 1 Direction	To S		Road X Slope (%)	2.1
	X Walk 1 Width (in)	N/A		Clear Space?	Yes

X Walk 1 Slope (%)	0.4	N/A	Clear Space to XWalk (in)	N/A
	X Walk 1 X Slope (%)	2.1	Yes	Storm Grate/Utility Hazard?	No
N/A	Ramp inside XWalk1?	N/A		Storm Grate/Utility Type	
Yes	Any Obstructions?	No			N/A
	Obstruction Type		Yes	Surface Condition? (G/P)	Good
		N/A	No	Curb Slope (%)	9.9

Possible Solutions:	
Remove & Replace Entire Ramp. Remove & Replace Gutter.	
	,
Surveyor Natae	
Surveyor Notes:	,
N/A	,
	,
PROW/ADA:	
Not Found, R304.5.3, R305.1.4,	
R302.7.2

Total Cost:	\$ 2350.00
