Access Compliance Report

Public Rights-of-Way

(Curb Ramps)

Intersection ID: 15243	Main Street: ALBEMARLE_RD	Cross Street: REGAL_OAKS_DR	Location: SE
ADA ID: 481378DEB48D	Ramp Type: Combination1Diag	Initial Pass/Fail: Fail	Overall Compliance: No
		Severity Score: 0

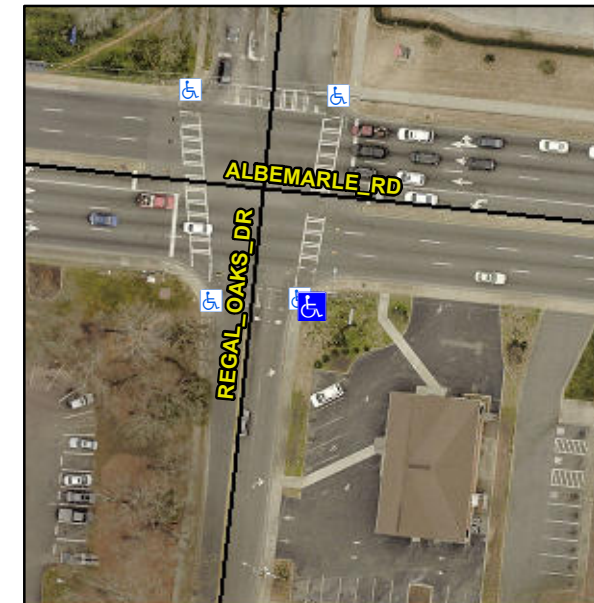
RP & RT RP < 5%

Not Found, R304.5.3, R304.3.2

Compliance	Description	Data	Compliance	Description	Data
N/A	Ramp Length LT (in)	28.0	N/A	Ramp Length RT (in)	45.0
Yes	Ramp Width LT (in)	62.0	Yes	Ramp Width RT (in)	62.0
No	Ramp Slope LT (%)	13.1	Yes	Ramp Slope RT (%)	4.8
Yes	Ramp XSlope LT (%)	1.3	No	Ramp XSlope RT (%)	4.7
N/A	Ramp Length (in)	61.0	Yes	Ramp Slope (%)	2.5
Yes	Ramp Width (in)	48.0	No	Ramp XSlope (%)	9.8
N/A	Flare Type LT	N/A	N/A	Flare Type RT	N/A
N/A	Flare Slope LT (%)	N/A	N/A	Flare Slope RT (%)	N/A
N/A	Flare Traversable LT?	N/A	N/A	Flare Traversable RT?	N/A
N/A	Landing Length (in)	N/A	N/A	DWS Provided?	N/A
N/A	Landing Width (in)	N/A	N/A	DWS Contrast?	N/A
N/A	Landing Slope (%)	N/A	N/A	DWS Length (in)	N/A
N/A	Landing X Slope (%)	N/A	N/A	DWS Full Width?	N/A
N/A	Landing Curb? (Y/N)	N/A	N/A	DWS Offset (in)	N/A
N/A	Shared Landing?	N/A			
N/A	Gutter Ponding?	N/A	N/A	Gutter Slope (%)	N/A
N/A	Gutter Lip Ht (in)	N/A	N/A	Gutter X Slope (%)	N/A
N/A	Painted X Walk1?	No	N/A	Painted X Walk2?	No

Remove & Replace Curb Ramp With Two New Directional Ramps or Equivalent.
