## **Access Compliance Report Public Rights-of-Way** (Curb Ramps)

Intersection ID: 14585 Main Street: RUBINE\_ST Cross Street: W\_TYVOLA\_RD Location: NE ADA ID: 4826D3E537D0 Ramp Type: Directional1 Initial Pass/Fail: Fail **Overall Compliance: No Severity Score:** 1.25

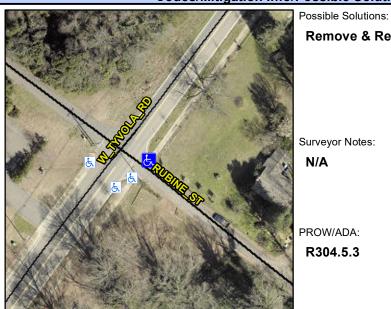
Field Measurements/Component Compliance							
	Compli	ance Description	Data	Compliance		Description	Data
	N/A	Ramp Length (in)	70.0	N/A	Grad	e Break?	N/A
	Yes	Ramp Width (in)	58.0	N/A	Grad	e Break Slope (%)	0.0
	Yes	Ramp Slope (%)	6.1	N/A	Grad	e Break XSlope (%)	0.0
	No	Ramp XSlope (%)	3.9				
	N/A	Flare Type LT	N/A	N/A	Flare	Type RT	N/A
	N/A	Flare Slope LT (%)	N/A	N/A	Flare	Slope RT (%)	0.0
	N/A	Flare Traversable LT?	N/A	N/A	Flare	Traversable RT?	N/A
	N/A	Landing Length (in)	0.0	N/A	DWS	Provided?	N/A
	N/A	Landing Width (in)	0.0	N/A	DWS	Contrast?	N/A
	N/A	Landing Slope (%)	0.0	N/A	DWS	Length (in)	N/A
	N/A	Landing X Slope (%)	0.0	N/A	DWS	Full Width?	N/A
	N/A	Landing Curb? (Y/N)	N/A	N/A	DWS	Offset LT (in)	N/A
	N/A	Shared Landing?	N/A	N/A	DWS	Offset RT (in)	N/A
	N/A	Gutter Ponding?	0.0	N/A	Gutte	er Slope (%)	N/A
	N/A	Gutter Lip Ht (in)	0.0	N/A	Gutte	er X Slope (%)	N/A
	N/A	Painted X Walk1?	No		Road	Slope (%)	2.0

X Walk 1 Direction	To SW		Road	X Slope (%)	0.9
		X Walk 1 Width (in)	N/A		Clear	Space?	N/A
		X Walk 1 Slope (%)	2.6	N/A	Clear	Space to XWalk (in)	N/A
		X Walk 1 X Slope (%)	0.9	N/A	Storn	n Grate/Utility Hazard?	N/A
	N/A	Ramp inside XWalk1?	N/A		Storn	n Grate/Utility Type	
	N/A	Any Obstructions?	N/A				N/A
		Obstruction Type		Yes	Surfa	ce Condition? (G/P)	Good
			N/A	N/A	Curb	Slope (%)	0.2

Remove & Replace Entire Ramp. Surveyor Notes: N/A PROW/ADA: R304.5.3
