Access Compliance Report

Public Rights-of-Way

(Curb Ramps)

Intersection ID: 5224	Main Street: FROSTMOOR_PL	Cross Street: GROVETON_CT	Location: SE
ADA ID: 484E52ECA417	Ramp Type: Perp	Initial Pass/Fail: Fail	Overall Compliance: No
		Severity Score: 50

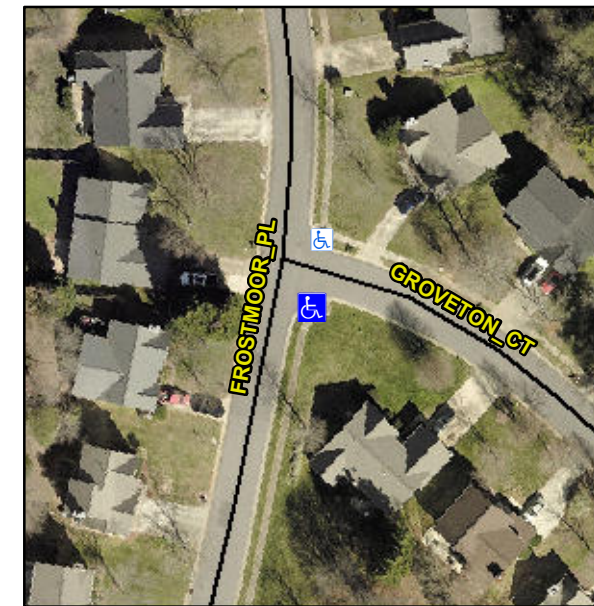
Not Found, R304.2.2, R304.5.3

Compliance	Description	Data	Compliance	Description	Data
N/A	Ramp Length (in)	48.0	No	Ramp Slope (%)	20.0
Yes	Ramp Width (in)	48.0	No	Ramp XSlope (%)	9.9
N/A	Flare Type LT	N/A	N/A	Flare Type RT	N/A
N/A	Flare Slope LT (%)	N/A	N/A	Flare Slope RT (%)	N/A
N/A	Flare Traversable LT?	N/A	N/A	Flare Traversable RT?	N/A
N/A	Landing Length (in)	N/A	N/A	DWS Provided?	N/A
N/A	Landing Width (in)	N/A	N/A	DWS Contrast?	N/A
N/A	Landing Slope (%)	N/A	N/A	DWS Length (in)	N/A
N/A	Landing X Slope (%)	N/A	N/A	DWS Full Width?	N/A
N/A	Landing Curb? (Y/N)	N/A	N/A	DWS Offset (in)	N/A
N/A	Shared Landing?	N/A			
N/A	Gutter Ponding?	N/A	N/A	Gutter Slope (%)	N/A
N/A	Gutter Lip Ht (in)	N/A	N/A	Gutter X Slope (%)	N/A
N/A	Painted X Walk1?	No	N/A	Painted X Walk2?	N/A
	X Walk 1 Direction	To N		X Walk 2 Direction	N/A
N/A	X Walk 1 Width (in)	N/A	N/A	X Walk 2 Width (in)	N/A
	X Walk 1 Slope (%)	1.6		X Walk 2 Slope (%)	N/A
	X Walk 1 X Slope (%)	7.0		X Walk 2 X Slope (%)	N/A

N/A	Ramp inside XWalk1?	N/A	N/A	Ramp inside XWalk2?	N/A
	Road Slope (%)	N/A	N/A	Clear Space?	N/A
	Road X Slope (%)	N/A	N/A	Clear Space to XWalk (in)	N/A
N/A	Any Obstructions?	N/A	N/A	Storm Grate/Utility Hazard?	N/A
	Obstruction Type			Storm Grate/Utility Type	
		N/A			N/A
			Yes	Surface Condition? (G/P)	Good

Remove & Replace Entire Ramp.

Total Cost: \$ 1850.00
