Access Compliance Report Public Rights-of-Way (Curb Ramps)

Intersection ID: 14851 Main Street: E_WORTHINGTON_AV Cross Street: PARK_RD Location: N

ADA ID: 48533C8CF8F3 Ramp Type: Directional1 Initial Pass/Fail: Fail Overall Compliance: No Severity Score: 13.75

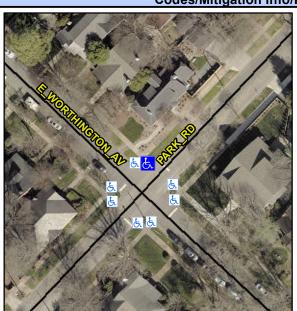
Possible Solution	n Field Measurements/Component Compliance							
Possible Solutions:			Compliance Description		Data	Compliance Description		
Remove & Replace Entire	Ram	p.	N/A	Ramp Length (in)	57.0	N/A	Grade Break?

•		-	Yes	Ramp Width (in)	48.0	N/A	Grade Break Slope (%)	
			No	Ramp Slope (%)	11.1	N/A	Grade Break XSlope (%)	
			No	Ramp XSlope (%)	3.9			
			N/A	Flare Type LT	N/A	N/A	Flare Type RT	
			N/A	Flare Slope LT (%)	N/A	N/A	Flare Slope RT (%)	
Surveyor Notes:			N/A	Flare Traversable LT?	N/A	N/A	Flare Traversable RT?	
N/A			N/A	Landing Length (in)	0.0	N/A	DWS Provided?	
			N/A	Landing Width (in)	0.0	N/A	DWS Contrast?	
			N/A	Landing Slope (%)	0.0	N/A	DWS Length (in)	
			N/A	Landing X Slope (%)	0.0	N/A	DWS Full Width?	
PROW/ADA:			N/A	Landing Curb? (Y/N)	N/A	N/A	DWS Offset LT (in)	
R304.2.2, R304.5.3			N/A	Shared Landing?	N/A	N/A	DWS Offset RT (in)	
			N/A	Gutter Ponding?	Yes	N/A	Gutter Slope (%)	
			N/A	Gutter Lip Ht (in)	0.0	N/A	Gutter X Slope (%)	
			N/A	Painted X Walk1?	No		Road Slope (%)	
				X Walk 1 Direction	To SE		Road X Slope (%)	
				X Walk 1 Width (in)	N/A		Clear Space?	
				X Walk 1 Slope (%)	3.7	N/A	Clear Space to XWalk (in)

X Walk 1 X Slope (%)	0.3	N/A	Storm Grate/Utility Hazard?	
			N/A	Ramp inside XWalk1?	N/A		Storm Grate/Utility Type	
			N/A	Any Obstructions?	N/A			
Total Cost:	\$	1600.00		Obstruction Type		Yes	Surface Condition? (G/P)
