Access Compliance Report

Public Rights-of-Way

(Curb Ramps)

Intersection ID: 2865	Main Street: DOWNFIELD_WOOD_DR	Cross Street: LADY_BANK_DR	Location: S
ADA ID: 485ED8146BB7	Ramp Type: Perp	Initial Pass/Fail: Fail	Overall Compliance: No
Codes/Mitigation Info/Possible Solution		Field Measurements/Component Compliance	
Severity Score: 26.25

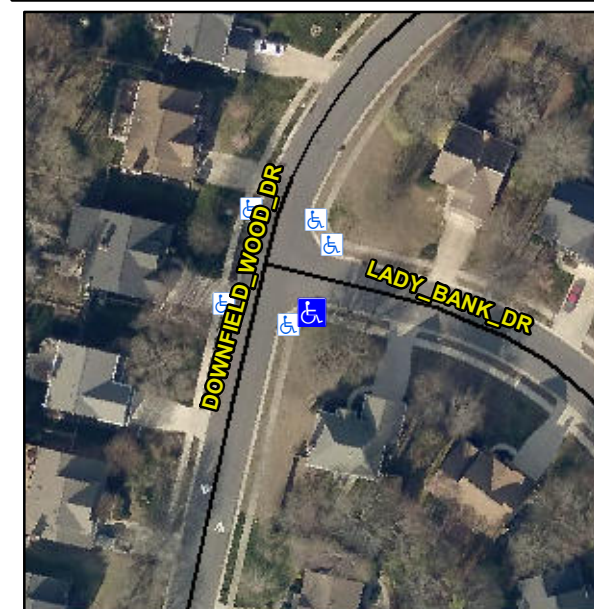
R304.2.2, R304.5.3

Compliance	Description	Data	Compliance	Description	Data
N/A	Ramp Length (in)	47.0	No	Ramp Slope (%)	15.0
Yes	Ramp Width (in)	48.0	No	Ramp XSlope (%)	3.2
N/A	Flare Type LT	N/A	N/A	Flare Type RT	N/A
N/A	Flare Slope LT (%)	N/A	N/A	Flare Slope RT (%)	N/A
N/A	Flare Traversable LT?	N/A	N/A	Flare Traversable RT?	N/A
N/A	Landing Length (in)	N/A	N/A	DWS Provided?	N/A
N/A	Landing Width (in)	N/A	N/A	DWS Contrast?	N/A
N/A	Landing Slope (%)	N/A	N/A	DWS Length (in)	N/A
N/A	Landing X Slope (%)	N/A	N/A	DWS Full Width?	N/A
N/A	Landing Curb? (Y/N)	N/A	N/A	DWS Offset (in)	N/A
N/A	Shared Landing?	N/A			
N/A	Gutter Ponding?	N/A	N/A	Gutter Slope (%)	N/A
N/A	Gutter Lip Ht (in)	N/A	N/A	Gutter X Slope (%)	N/A
N/A	Painted X Walk1?	No	N/A	Painted X Walk2?	N/A
	X Walk 1 Direction	To NE		X Walk 2 Direction	N/A
N/A	X Walk 1 Width (in)	N/A	N/A	X Walk 2 Width (in)	N/A
	X Walk 1 Slope (%)	2.4		X Walk 2 Slope (%)	N/A
	X Walk 1 X Slope (%)	2.6		X Walk 2 X Slope (%)	N/A

N/A	Ramp inside XWalk1?	N/A	N/A	Ramp inside XWalk2?	N/A
	Road Slope (%)	N/A	N/A	Clear Space?	N/A
	Road X Slope (%)	N/A	N/A	Clear Space to XWalk (in)	N/A
N/A	Any Obstructions?	N/A	N/A	Storm Grate/Utility Hazard?	N/A
	Obstruction Type			Storm Grate/Utility Type	
		N/A			N/A
			Yes	Surface Condition? (G/P)	Good

Possible Solutions:

Remove & Replace Entire Ramp.

Total Cost: \$ 1850.00
