# Access Compliance Report

## Public Rights-of-Way

### (Curb Ramps)

Intersection ID: 30240	Main Street: OLD_PLANK_RD	Cross Street: MCGINN GROVE DR	Location: SE
ADA ID: 48726CFE1B5A	Ramp Type: Perp	Initial Pass/Fail: Fail	Overall Compliance: No
Codes/Mitigation Info/Possible Solution		Field Measurements/Component Compliance	
Severity Score: 33.75

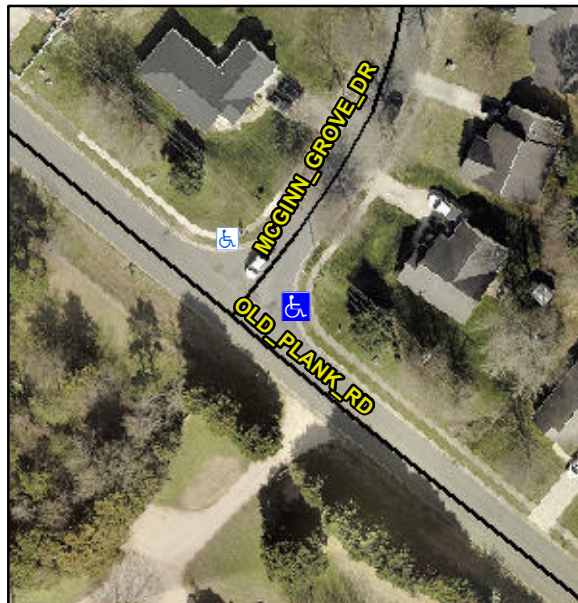
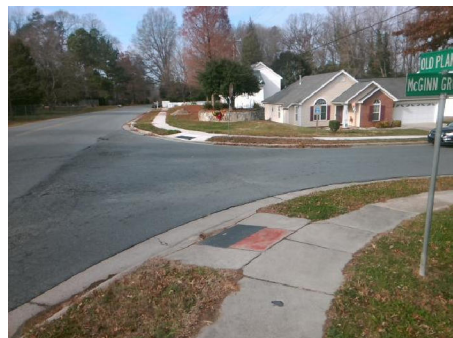
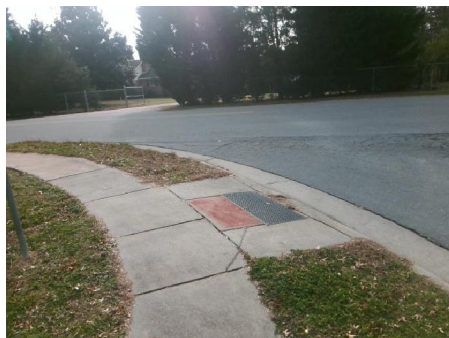
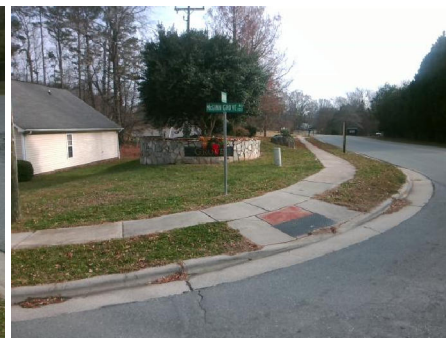
**Not Found, R304.5.1, R304.2.2, R304.5.3**

Compliance	Description	Data	Compliance	Description	Data
N/A	Ramp Length (in)	49.0	No	Ramp Slope (%)	11.6
No	Ramp Width (in)	42.5	No	Ramp XSlope (%)	6.4
N/A	Flare Type LT	N/A	N/A	Flare Type RT	N/A
N/A	Flare Slope LT (%)	N/A	N/A	Flare Slope RT (%)	N/A
N/A	Flare Traversable LT?	N/A	N/A	Flare Traversable RT?	N/A
N/A	Landing Length (in)	N/A	N/A	DWS Provided?	N/A
N/A	Landing Width (in)	N/A	N/A	DWS Contrast?	N/A
N/A	Landing Slope (%)	N/A	N/A	DWS Length (in)	N/A
N/A	Landing X Slope (%)	N/A	N/A	DWS Full Width?	N/A
N/A	Landing Curb? (Y/N)	N/A	N/A	DWS Offset (in)	N/A
N/A	Shared Landing?	N/A			
N/A	Gutter Ponding?	N/A	N/A	Gutter Slope (%)	N/A
N/A	Gutter Lip Ht (in)	N/A	N/A	Gutter X Slope (%)	N/A
N/A	Painted X Walk1?	No	N/A	Painted X Walk2?	N/A
	X Walk 1 Direction	To NW		X Walk 2 Direction	N/A
N/A	X Walk 1 Width (in)	N/A	N/A	X Walk 2 Width (in)	N/A
	X Walk 1 Slope (%)	2.7		X Walk 2 Slope (%)	N/A
	X Walk 1 X Slope (%)	7.1		X Walk 2 X Slope (%)	N/A

N/A	Ramp inside XWalk1?	N/A	N/A	Ramp inside XWalk2?	N/A
	Road Slope (%)	N/A	N/A	Clear Space?	N/A
	Road X Slope (%)	N/A	N/A	Clear Space to XWalk (in)	N/A
N/A	Any Obstructions?	N/A	N/A	Storm Grate/Utility Hazard?	N/A
	Obstruction Type			Storm Grate/Utility Type	
		N/A			N/A
			Yes	Surface Condition? (G/P)	Good

**Remove & Replace Entire Ramp.**
