# Access Compliance Report

## Public Rights-of-Way

### (Curb Ramps)

| Intersection ID: 23662 | Main Street: CARMEL_RD | Cross Street: RED_OAK_LN | Location: NE |

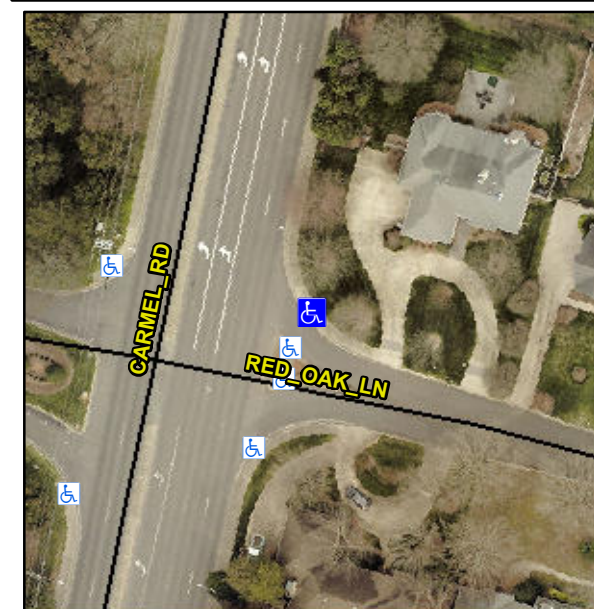
| ADA ID: 48779420006C | Ramp Type: Perp | Initial Pass/Fail: Fail | Overall Compliance: No |
| Severity Score: 13.75 | | | |

| Compliance | Description | Data | Compliance | Description | Data |
|---|---|---|---|---|---|
| N/A | Ramp Length (in) | 55.0 | No | Ramp Slope (%) | 8.8 |
| Yes | Ramp Width (in) | 52.0 | No | Ramp XSlope (%) | 3.0 |

**Remove & Replace Entire Ramp.**

**R304.2.2, R304.5.3**

Total Cost: \$ 1850.00
