# Access Compliance Report

## Public Rights-of-Way

### (Curb Ramps)

Intersection ID: 31545	Main Street: ADA_CT	Cross Street: CALDWELL_RIDGE_PY	Location: W
ADA ID: 487BC0338131	Ramp Type: PerpDiag	Initial Pass/Fail: Fail	Overall Compliance: No
Codes/Mitigation Info/Possible Solution		Field Measurements/Component Compliance

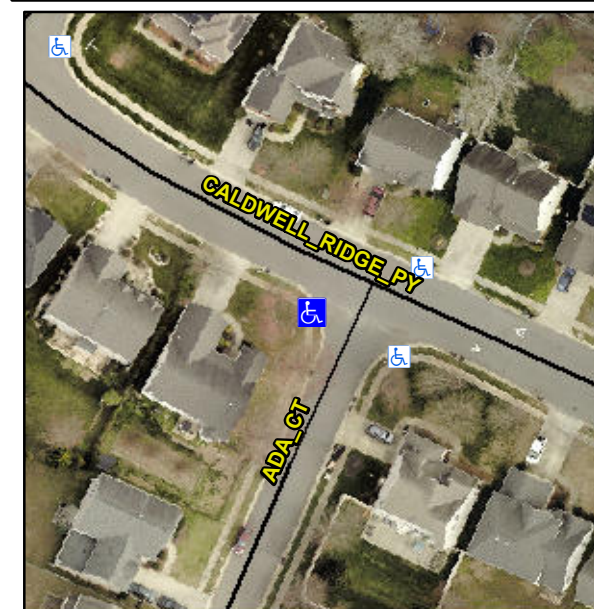
**Not Found, R304.5.1, R304.2.2**

Compliance	Description	Data	Compliance	Description	Data
N/A	Ramp Length (in)	45.0	No	Ramp Slope (%)	9.1
No	Ramp Width (in)	47.0	Yes	Ramp XSlope (%)	1.1
N/A	Flare Type LT	N/A	N/A	Flare Type RT	N/A
N/A	Flare Slope LT (%)	N/A	N/A	Flare Slope RT (%)	N/A
N/A	Flare Traversable LT?	N/A	N/A	Flare Traversable RT?	N/A
N/A	Landing Length (in)	N/A	N/A	DWS Provided?	N/A
N/A	Landing Width (in)	N/A	N/A	DWS Contrast?	N/A
N/A	Landing Slope (%)	N/A	N/A	DWS Length (in)	N/A
N/A	Landing X Slope (%)	N/A	N/A	DWS Full Width?	N/A
N/A	Landing Curb? (Y/N)	N/A	N/A	DWS Offset (in)	N/A
N/A	Shared Landing?	N/A			
N/A	Gutter Ponding?	N/A	N/A	Gutter Slope (%)	N/A
N/A	Gutter Lip Ht (in)	N/A	N/A	Gutter X Slope (%)	N/A
N/A	Painted X Walk1?	No	N/A	Painted X Walk2?	No
	X Walk 1 Direction	To SE		X Walk 2 Direction	To N
N/A	X Walk 1 Width (in)	N/A	N/A	X Walk 2 Width (in)	N/A
	X Walk 1 Slope (%)	2.4		X Walk 2 Slope (%)	1.1
	X Walk 1 X Slope (%)	1.2		X Walk 2 X Slope (%)	1.7

N/A	Ramp inside XWalk1?	N/A	N/A	Ramp inside XWalk2?	N/A
	Road Slope (%)	0.2	N/A	Clear Space?	N/A
	Road X Slope (%)	1.4	N/A	Clear Space to XWalk (in)	N/A
N/A	Any Obstructions?	N/A	N/A	Storm Grate/Utility Hazard?	N/A
	Obstruction Type			Storm Grate/Utility Type	
		N/A			N/A
			Yes	Surface Condition? (G/P)	Good

**Remove & Replace Curb Ramp With Two New Directional Ramps or Equivalent.**
