# Access Compliance Report

## Public Rights-of-Way

### (Curb Ramps)

Intersection ID: 10020383	Main Street: BALLANTYNE COUNTRY CLUB DR	Cross Street: N/A	Location: S
ADA ID: 487EE84E1784	Ramp Type: PerpDiag	Initial Pass/Fail: Fail	Overall Compliance: No
Codes/Mitigation Info/Possible Solution		Field Measurements/Component Compliance	
Severity Score: 12.5

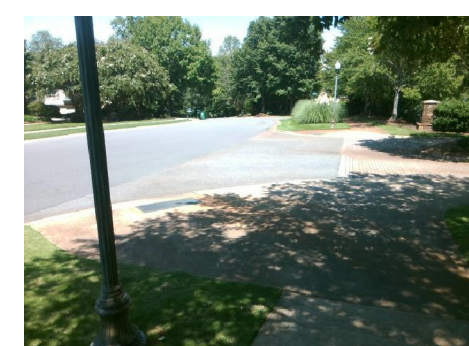
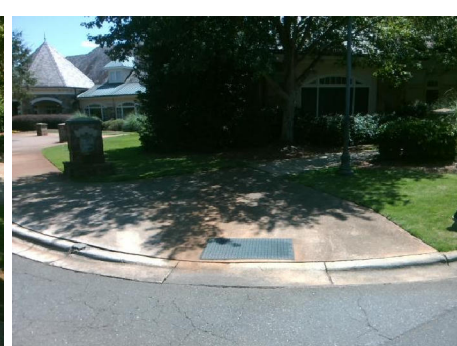
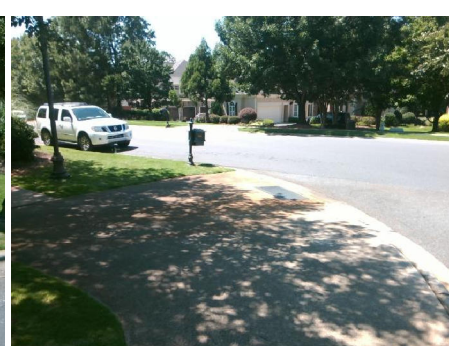
X Walk 1 X Slope (%)	0.1
		N/A	Ramp inside XWalk1?	N/A
			Road Slope (%)	0.8
			Road X Slope (%)	0.4
		N/A	Any Obstructions?	N/A
			Obstruction Type	
		N/A		N/A
		Yes	Surface Condition? (G/P)	Good
