# Access Compliance Report

## Public Rights-of-Way

### (Curb Ramps)

| Intersection ID: 8592 | Main Street: PERIWINKLE_HILL_AV | Cross Street: IKEA_BV | Location: S |

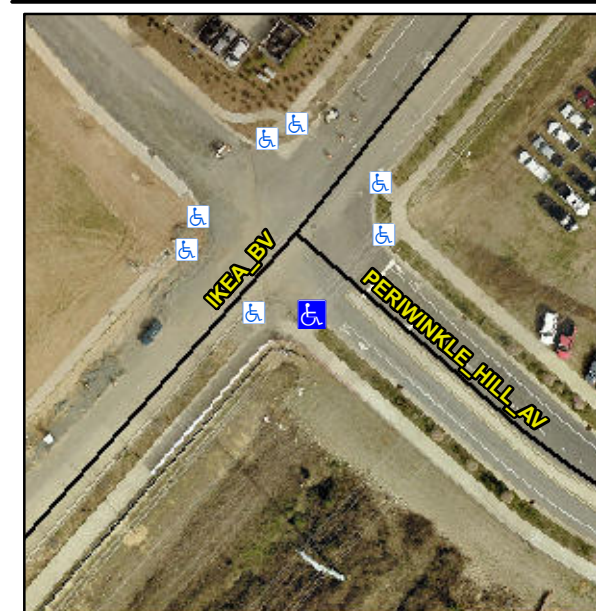
**Not Found, R304.5.3, R305.2**

| Compliance | Description | Data | Compliance | Description | Data |
|---|---|---|---|---|---|
| Yes | Ramp Width (in) | 71.0 | No | Ramp XSlope (%) | 3.0 |
| No | Landing X Slope (%) | 2.5 | Yes | DWS Full Width? | Yes |
| N/A | Landing Curb? (Y/N) | No | No | DWS Offset (in) | 3.0 |
| Yes | Gutter Lip Ht (in) | 0.0 | No | Gutter X Slope (%) | 2.7 |

**Remove & Replace Entire Ramp.  
Remove & Replace Gutter.**

Total Cost: \$ 2600.00

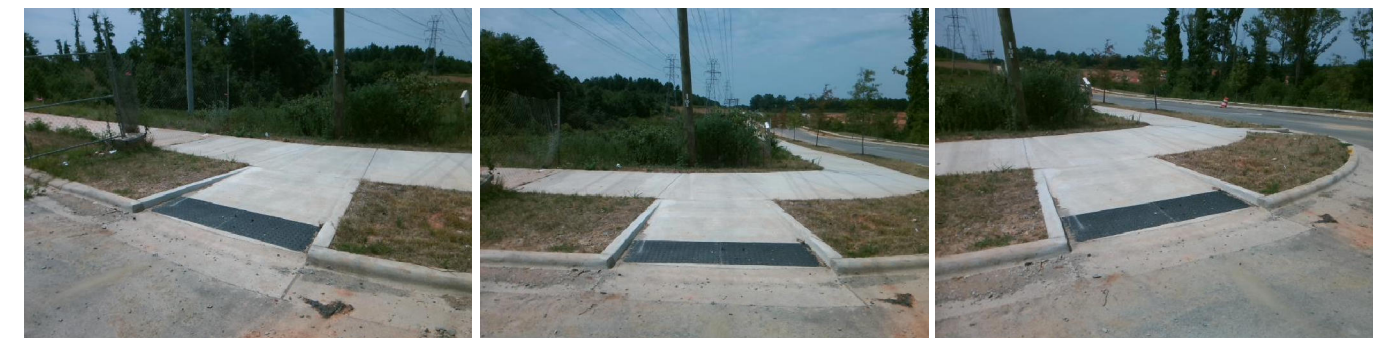
| ADA ID: 4892C4EA9019 | Ramp Type: Perp | Initial Pass/Fail: Pass | Overall Compliance: No |
| Severity Score: 0.25 | | | |
