## Access Compliance Report Public Rights-of-Way (Curb Ramps)

Intersection ID: 1000735 Main Street: HIGHLAND_CREEK_PY					Street:	RIDGE_RD	Location:	NW		
ADA ID: 4894F38C39EF Ramp Type: Perp				Initial Pass/Fail: Pass Overall Compliance: No					o Severity Score:	15
Codes/Mitigation Info/Possible Solution				Field Measurements/Component Compliance						
	KING DIRORS A.	Possible Solutions:	Compliance Description			Data	Data Compliance Description			
A CARLEN AND		Remove & Replace Landing.			N/A	Ramp Length (in)	83.0	Yes	Ramp Slope (%)	7.8
CONTRACT A CA-	N Ala	Remove & Replace Gutter.	•		Yes	Ramp Width (in)	48.0	Yes	Ramp XSlope (%)	0.0
1 1 1 1 1 1 1 1 1 1 1 1 1 1 1 1 1 1 1		· · · · · · ·			N/A	Flare Type LT	Sloped	N/A	Flare Type RT	N/A
	E III				N/A	Flare Slope LT (%)	11.2	N/A	Flare Slope RT (%)	7.5
A MADE THE SEA				N/A	Flare Traversable LT?	No	N/A	Flare Traversable RT?	No	
THE SUPPLY AND				Yes	Landing Length (in)	58.0	Yes	DWS Provided?	Yes	
	Surveyor Notes:			Yes	Landing Width (in)	60.0	Yes	DWS Contrast?	Yes

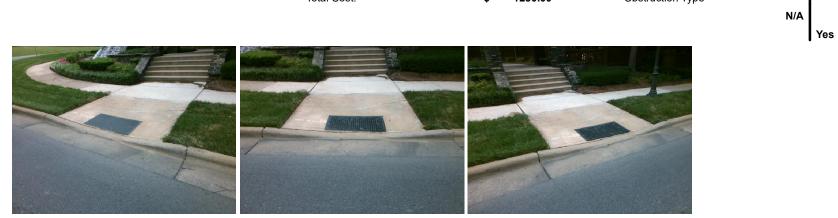
N/A				No	Landing Slope (%)	2.6	Yes	DWS Length (in)	25.5	
				Yes	Landing X Slope (%)	0.5	Yes	DWS Full Width?	Yes	
				N/A	Landing Curb? (Y/N)	No	Yes	DWS Offset (in)	1.5	
					N/A	Shared Landing?	No			
	PROW/ADA:			Yes	Gutter Ponding?	No	Yes	Gutter Slope (%)	0.6	
R304.2.2-Perp, R304.3.2-Par R302.7.2, R304.5.3			a.		No	Gutter Lip Ht (in)	1.5	No	Gutter X Slope (%)	3.5
			,		N/A	Painted X Walk1?	No	N/A	Painted X Walk2?	N/A
						X Walk 1 Direction	To E		X Walk 2 Direction	N/A
					N/A	X Walk 1 Width (in)	N/A	N/A	X Walk 2 Width (in)	N/A
Street 1 Name	HIGHLAND CREEK PY	_				X Walk 1 Slope (%)	4.0		X Walk 2 Slope (%)	N/A
Stop Condition-Street 2	None					X Walk 1 X Slope (%)	2.8		X Walk 2 X Slope (%)	N/A
Street 2 Name	N/A				N/A	Ramp inside XWalk1?	N/A	N/A	Ramp inside XWalk2?	N/A
Stop Condition-Street 1	N/A					Road Slope (%)	N/A	N/A	Clear Space?	Yes
						Road X Slope (%)	N/A	N/A	Clear Space to XWalk (in)	N/A

Yes	Any Obstructions?	No	Yes	Storm Grate/Utility Hazard?	No
		Total Cost: \$	; '	1250.00		Obstruction Type			Storm Grate/Utility Type	
							N/A			N/A

s Surface Condition? (G/P)

Good
