Access Compliance Report Public Rights-of-Way (Curb Ramps)

Cross Street: CALDWELL RIDGE PY Intersection ID: 31553 Main Street: CALDWELL RD Location: SE Initial Pass/Fail: Fail **Overall Compliance: No ADA ID: 48A16CEDDA97** Ramp Type: Combination2 **Severity Score:** 8.75

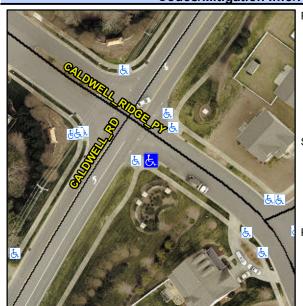
StopSign Street 1 Name **CALDWELL RIDGE PY** Stop Condition-Street 1 Street 2 Name N/A Stop Condition-Street 2 N/A Possible Solutions: Remove & Replace Entire Ramp. Surveyor Notes: LT RP < 5% PROW/ADA: Not Found, R304.5.1
