## Access Compliance Report Public Rights-of-Way (Curb Ramps)

Intersection ID: 28107 Main Street: KNIGHTSDALE\_DR Cross Street: MITCHELL\_GLEN\_DR Location: SW

ADA ID: 48A2F082B81D Ramp Type: BlendTrans2 Initial Pass/Fail: Fail Overall Compliance: No Severity Score: 12.5

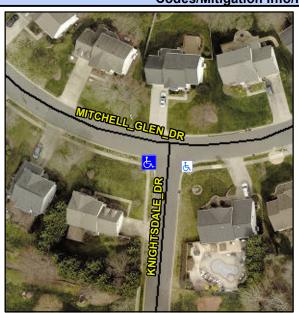
Not Found, R304.5.3

| N/A | Ramp Length (in) | 96.0 | Yes | BlendTrans Slope (%) | 4.3 |
|---|---|---|---|---|---|
| Yes | Ramp Width (in) | 49.0 | No | BlendTrans XSlope (%) | 5.4 |
| | | | No | Curb Slope (%) | 11.3 |

Remove & Replace Curb Ramp With Two New Directional Ramps or Equivalent.

Total Cost: \$ 3200.00
