Access Compliance Report

Public Rights-of-Way

(Curb Ramps)

Intersection ID: 7225	Main Street: STATESVILLE_RD	Cross Street: STARITA_RD	Location:	NE
ADA ID: 48A4BA178863	Ramp Type: Perp	Initial Pass/Fail: Fail	Overall Compliance: No	Severity Score: 10
Codes/Mitigation Info/Possible Solution		Field Measurements/Component Compliance

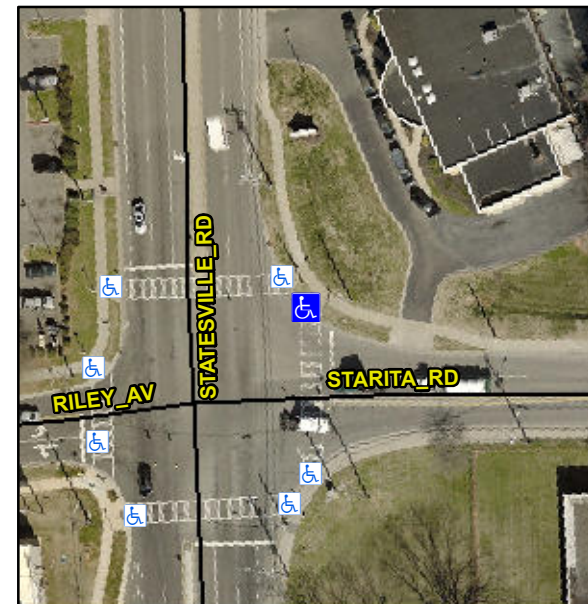
Not Found, R304.5.1, R304.5.3

Compliance	Description	Data	Compliance	Description	Data
N/A	Ramp Length (in)	120.5	Yes	Ramp Slope (%)	7.5
No	Ramp Width (in)	47.0	No	Ramp XSlope (%)	4.3
N/A	Flare Type LT	N/A	N/A	Flare Type RT	N/A
N/A	Flare Slope LT (%)	N/A	N/A	Flare Slope RT (%)	N/A
N/A	Flare Traversable LT?	N/A	N/A	Flare Traversable RT?	N/A
N/A	Landing Length (in)	N/A	N/A	DWS Provided?	N/A
N/A	Landing Width (in)	N/A	N/A	DWS Contrast?	N/A
N/A	Landing Slope (%)	N/A	N/A	DWS Length (in)	N/A
N/A	Landing X Slope (%)	N/A	N/A	DWS Full Width?	N/A
N/A	Landing Curb? (Y/N)	N/A	N/A	DWS Offset (in)	N/A
N/A	Shared Landing?	N/A			
N/A	Gutter Ponding?	N/A	N/A	Gutter Slope (%)	N/A
N/A	Gutter Lip Ht (in)	N/A	N/A	Gutter X Slope (%)	N/A
N/A	Painted X Walk1?	Yes	N/A	Painted X Walk2?	N/A
	X Walk 1 Direction	To S		X Walk 2 Direction	N/A
N/A	X Walk 1 Width (in)	110.0	N/A	X Walk 2 Width (in)	N/A
	X Walk 1 Slope (%)	5.0		X Walk 2 Slope (%)	N/A
	X Walk 1 X Slope (%)	4.2		X Walk 2 X Slope (%)	N/A

N/A	Ramp inside XWalk1?	Yes	N/A	Ramp inside XWalk2?	N/A
	Road Slope (%)	N/A	N/A	Clear Space?	N/A
	Road X Slope (%)	N/A	N/A	Clear Space to XWalk (in)	N/A
N/A	Any Obstructions?	N/A	N/A	Storm Grate/Utility Hazard?	N/A
	Obstruction Type			Storm Grate/Utility Type	
		N/A			N/A
			Yes	Surface Condition? (G/P)	Good

Remove & Replace Entire Ramp.
